City of Los Angeles

REPORT ON APPEAL FROM DETERMINATION OF SUPERINTENDENT OF BUILDING  
REFERRED TO THE BBSC WITHOUT RECOMMENDATION FROM THE COMMISSION STAFF

BOARD FILE: 210036  
C.D.: 5 (Councilmember Paul Koretz)  
PLANNING AREA: West Los Angeles  
ZONE: [Q]RD1.5-1  
BUREAU/DIV.: Inspection/Grading  
DISTRICT OFFICE: West Los Angeles  
PRIOR BOARD ACTION: No  
ORDER: No

JOB ADDRESS: 1751 1-12 – 1759 SOUTH MALCOLM AVENUE &  
1772 – 1774 1-6 SOUTH GLENDON AVENUE

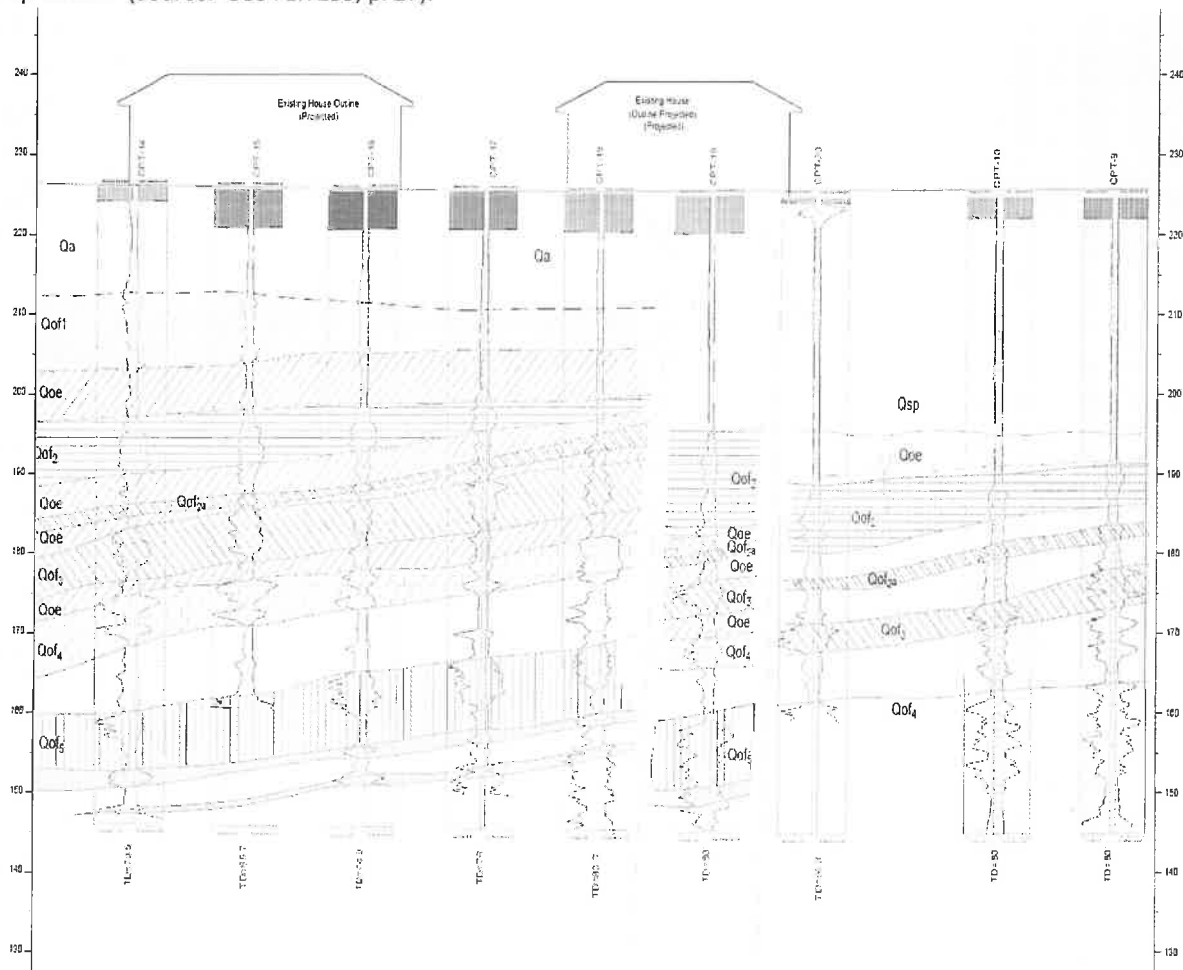
**CGS FER 259, Figure 16** - Portion of geologic cross section A-A' constructed along Malcolm Avenue by AES (2015b, Drawing 2) looking west. Note the thick sequence of Holocene "sag pond" deposits (Qsp) faulted against broadly folded Pleistocene older fan (Qof) and older estuarine (Qoe) deposits in apparent north-side-down vertical separation. (Source: CGS FER 259, p. 27).

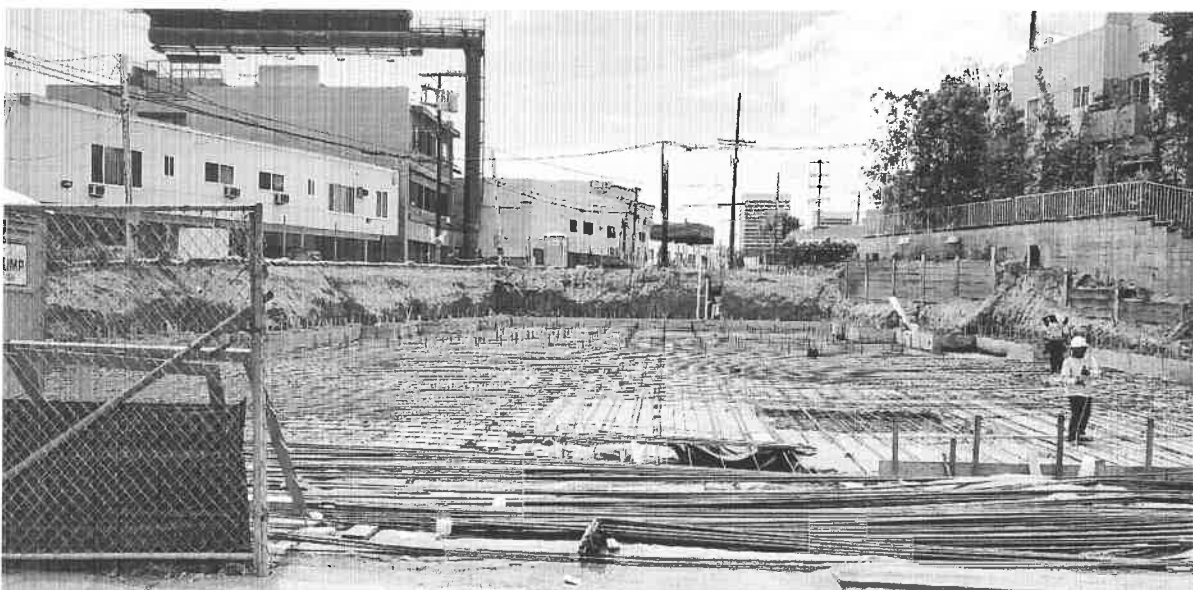
1751 Malcolm Avenue is built over the active fault viewed from Malcolm Ave. (Source: Fix the City).

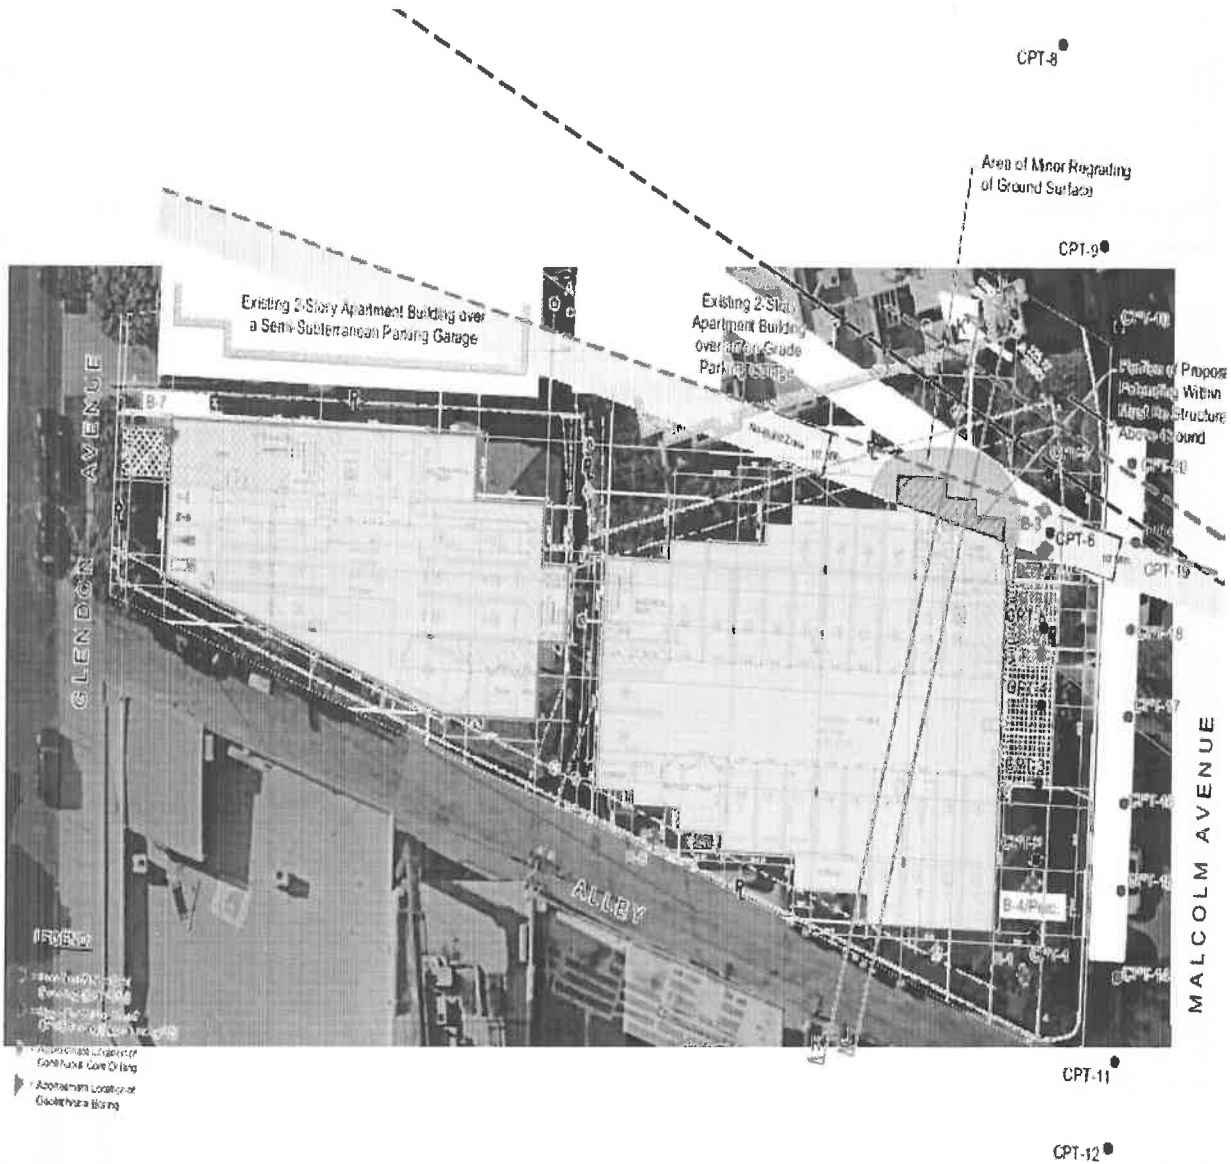
Figure 1. Fault line at southern boundary of 1772 Glendon Avenue not investigated – requires 50-foot setback.

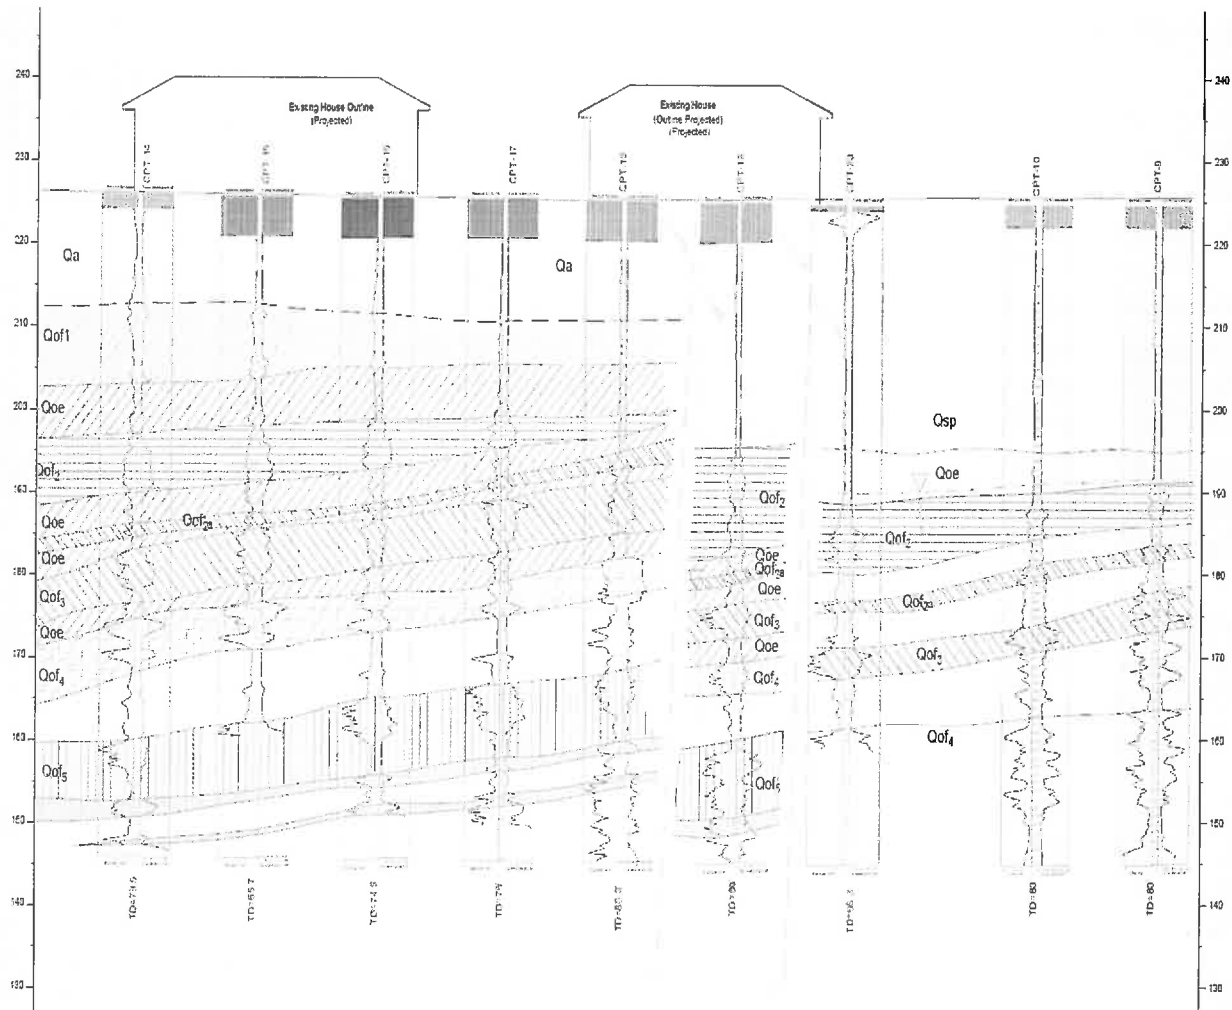
**Figure 3** CGS Figure 16: Portion of geologic cross section A-A" constructed along Malcolm Avenue by AES (2015b), Drawing 2) looking west. Note the thick sequence of Holocene "sag pond" deposits (Qsp) faulted against broadly folded Pleistocene older fan (Qof) and older estuarine (Qoe) deposits in apparent north-south-sown vertical separation. Source: CGS FER 259, p. 27.

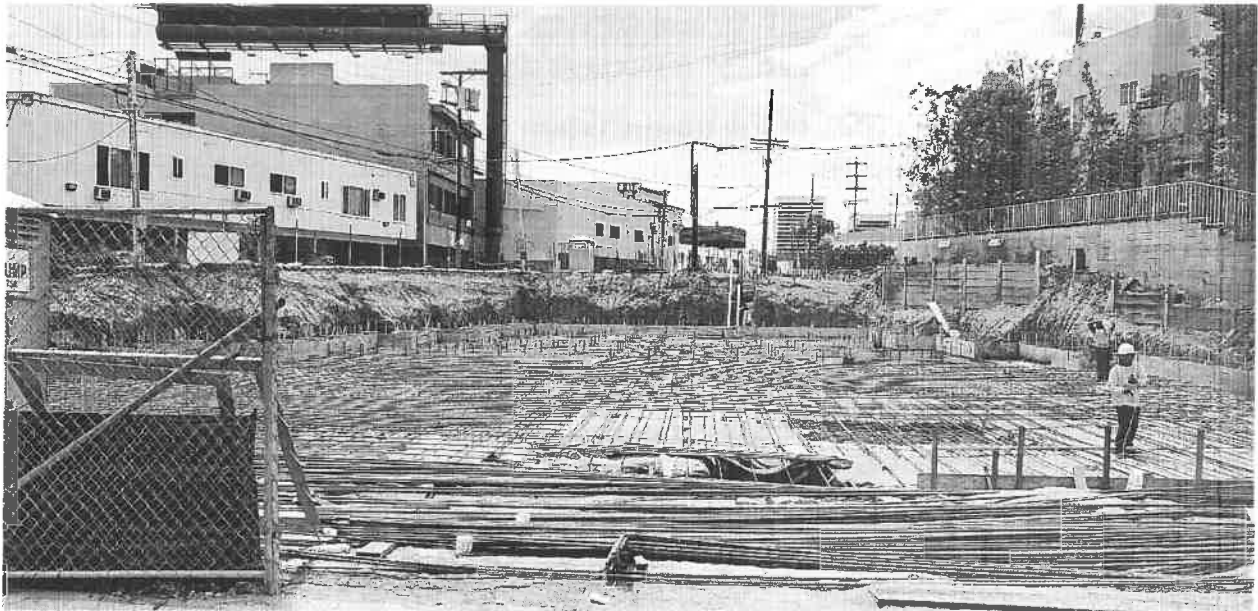
1751 Malcolm Avenue is built over the active fault viewed from Malcolm Ave. (Source: Fix the City).

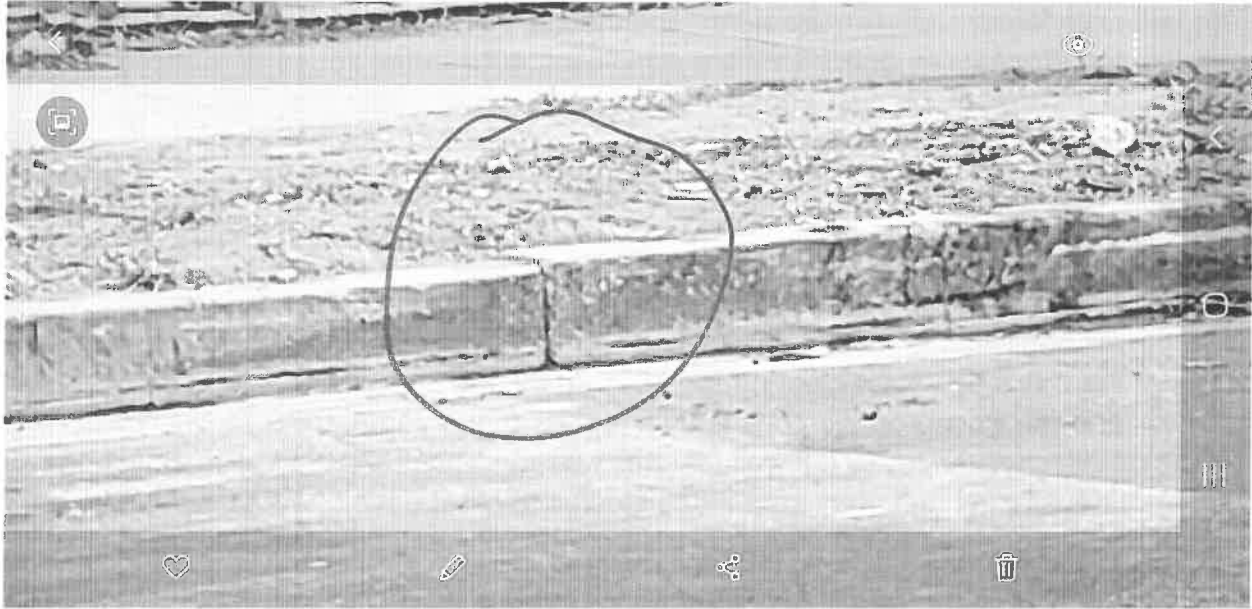
*Figure 4 broken curb at fault between CPT 18 and 19*

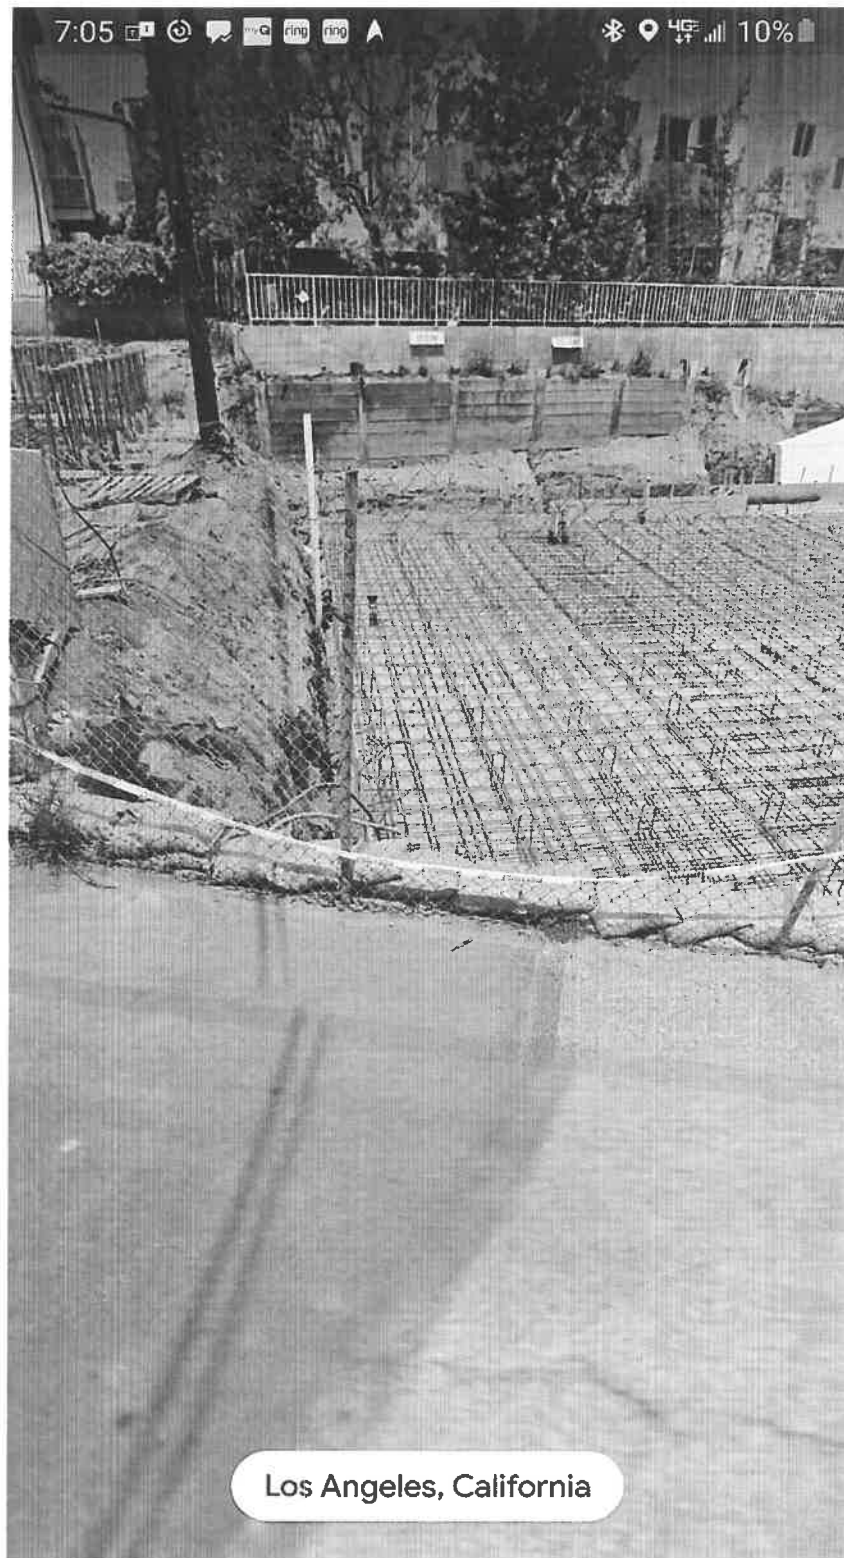
Figure 6 Fault in alley visible

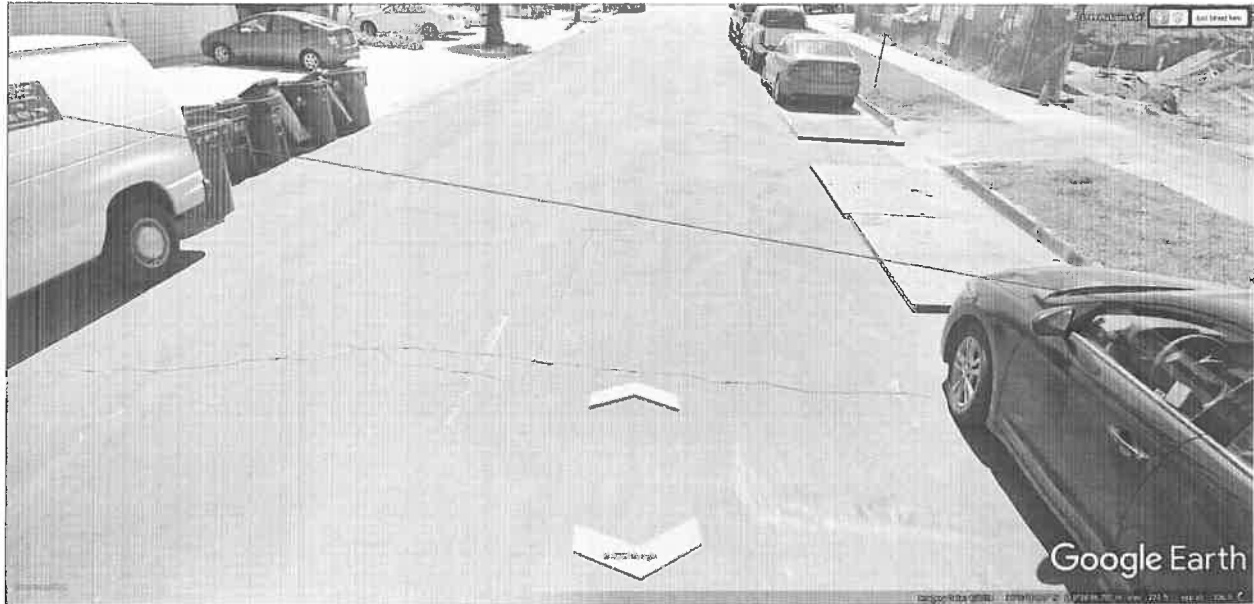
*Figure 7 Fault runs across Malcolm into site. Roadway cracks from surface faulting run into site.*

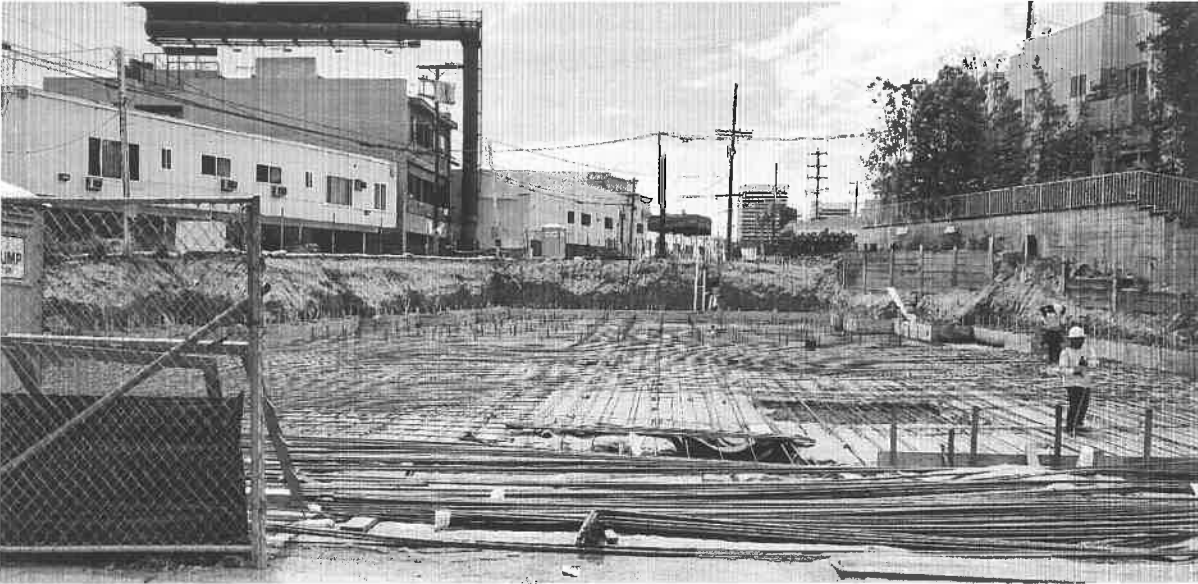
1751 Malcolm Avenue is built over the active fault viewed from Malcolm Ave. (Source: Fix the City).

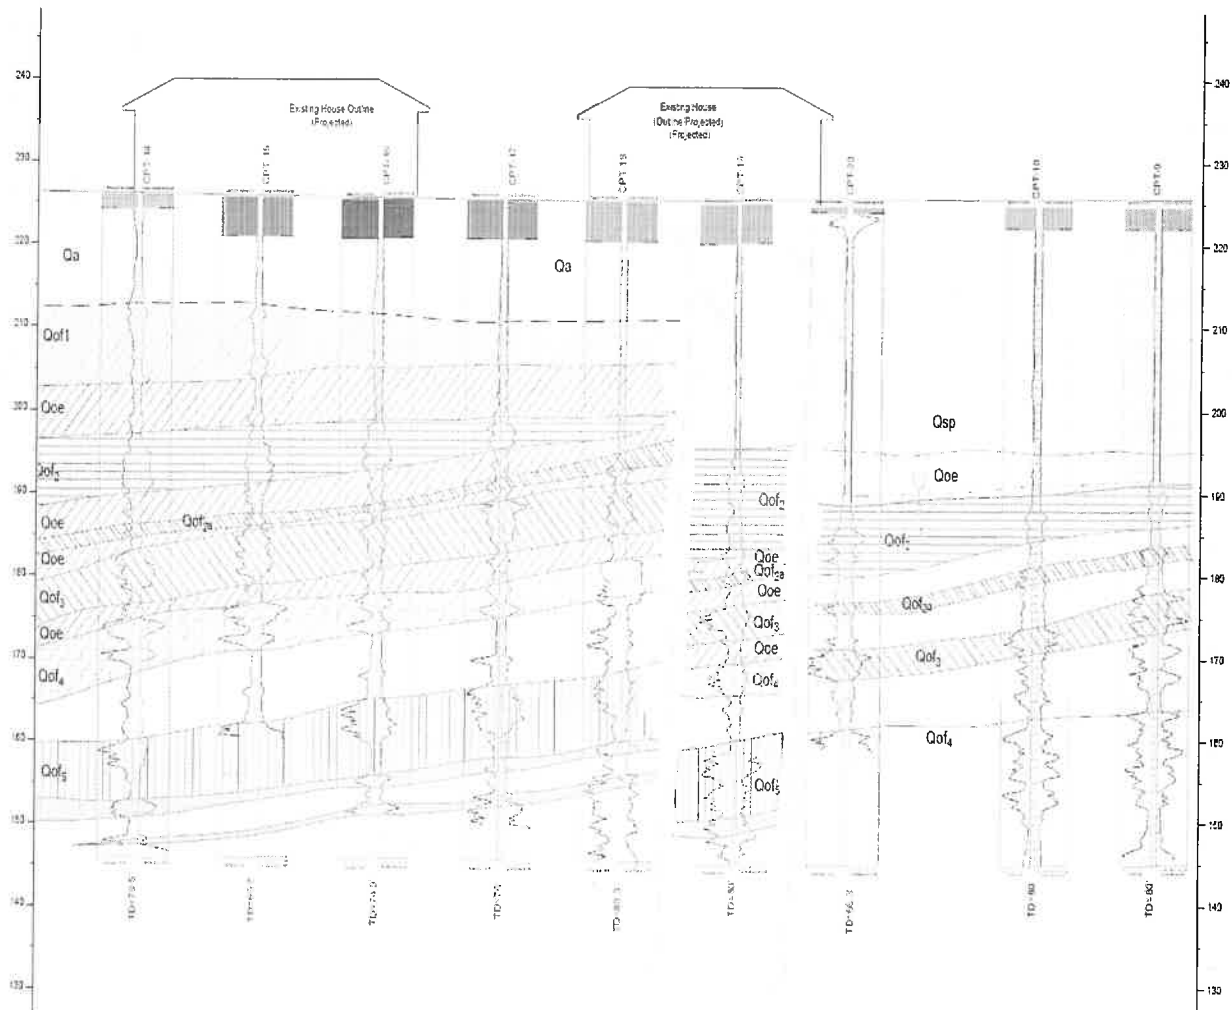
**Figure 3** CGS Figure 16: Portion of geologic cross section A-A" constructed along Malcolm Avenue by AES (2015b), Drawing 2) looking west. Note the thick sequence of Holocene "sag pond" deposits (Qsp) faulted against broadly folded Pleistocene older fan (Qof) and older estuarine (Qoe) deposits in apparent north-south-sown vertical separation. Source: CGS FER 259, p. 27.

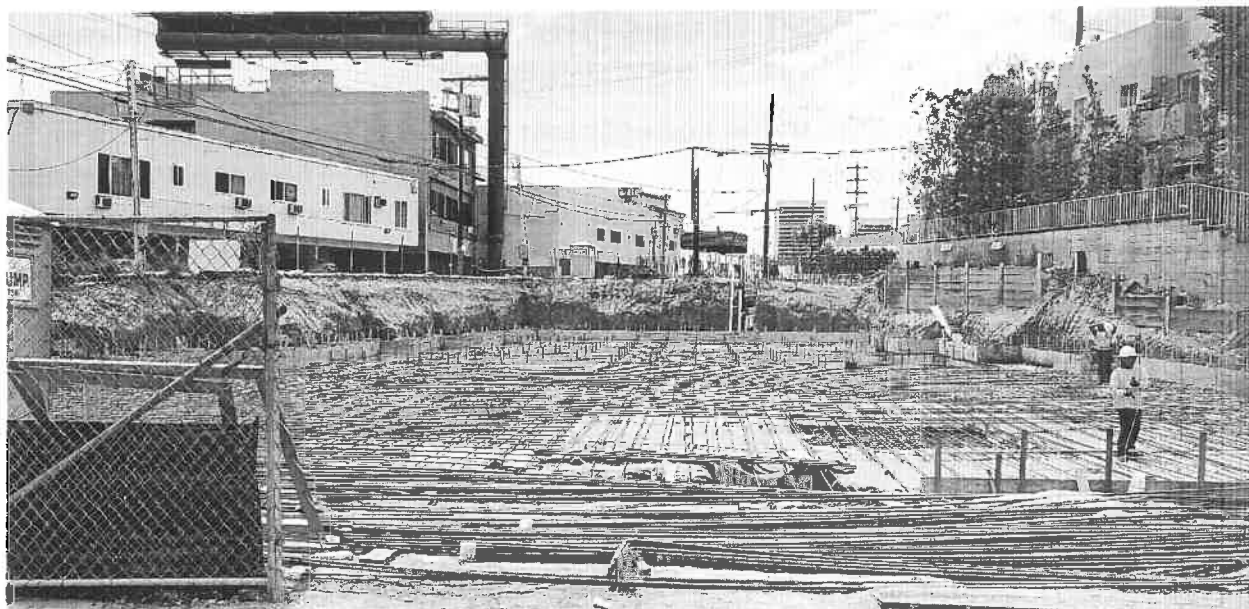
1751 Malcolm Avenue is built over the active fault viewed from Malcolm Ave. (Source: Fix the City).

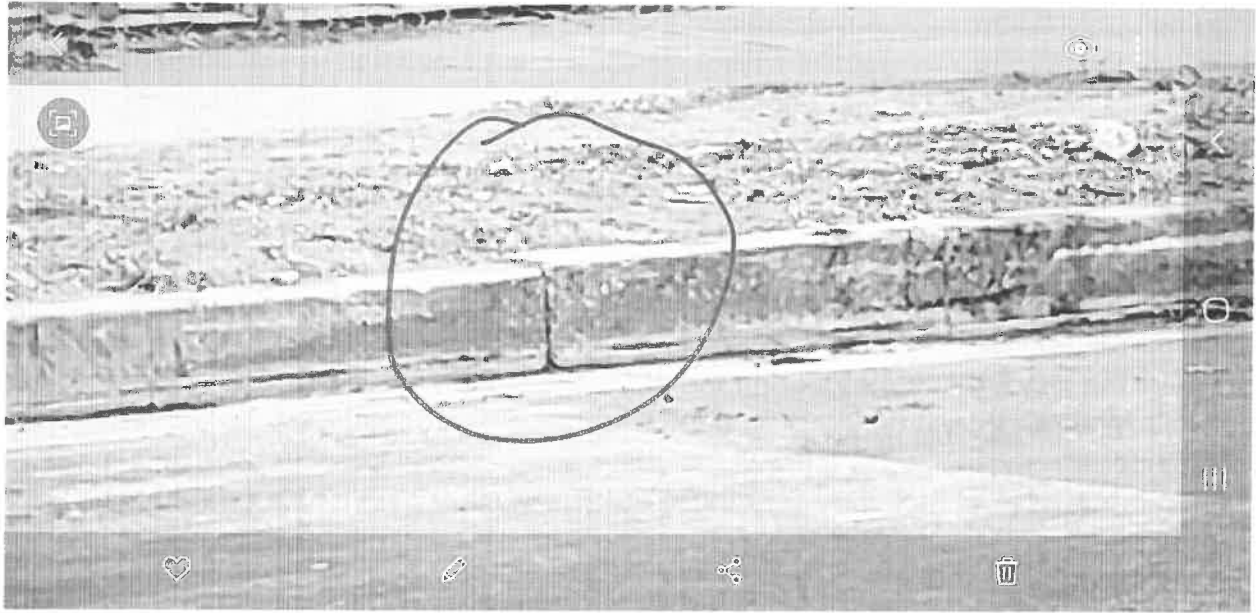
*Figure 4 broken curb at fault between CPT 18 and 19*

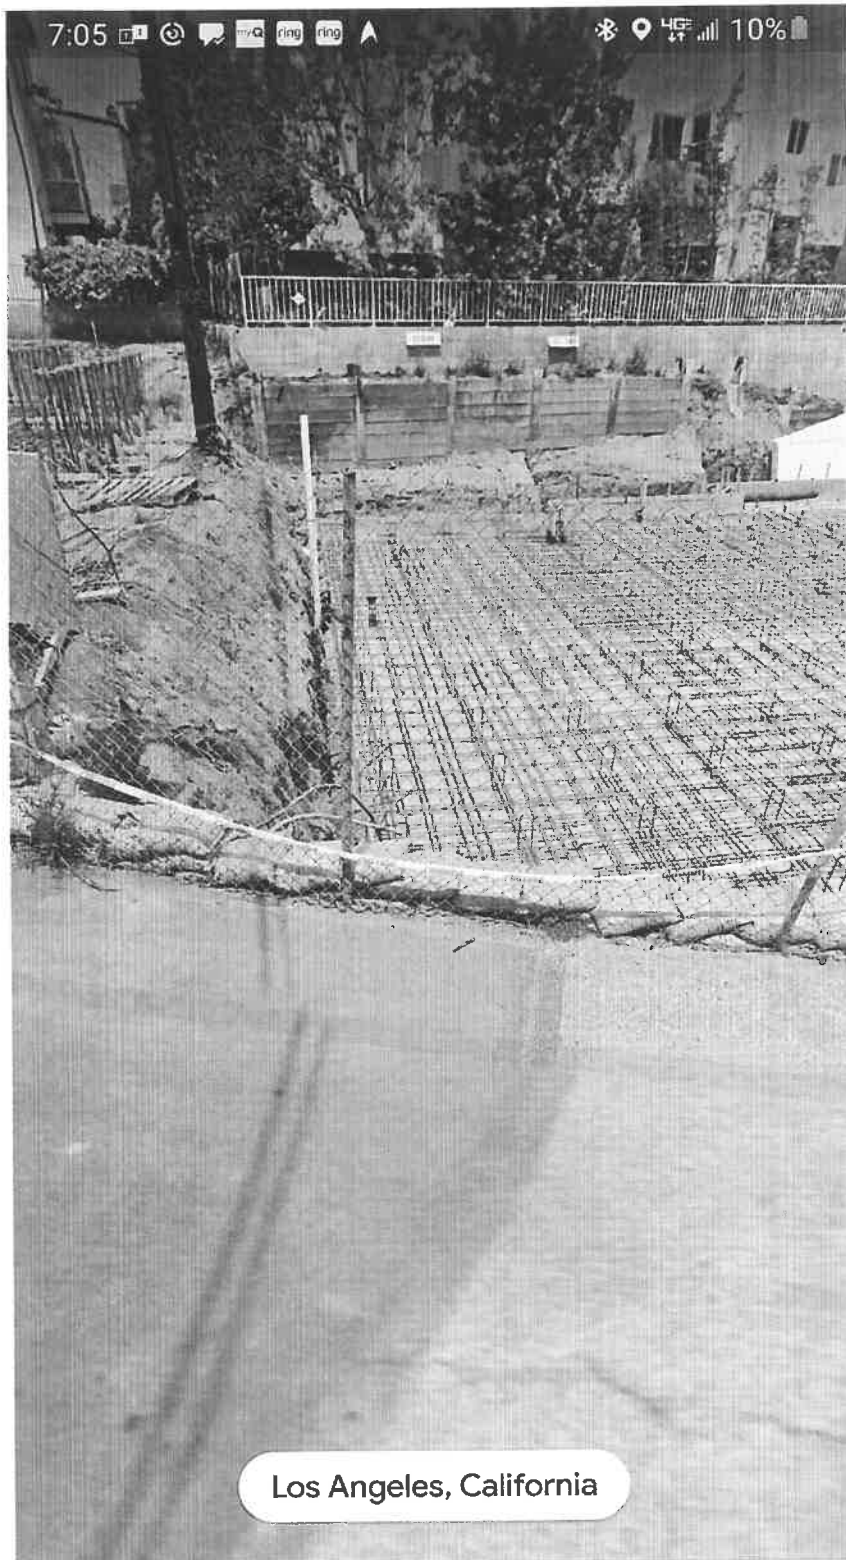
Figure 6 Fault in alley visible

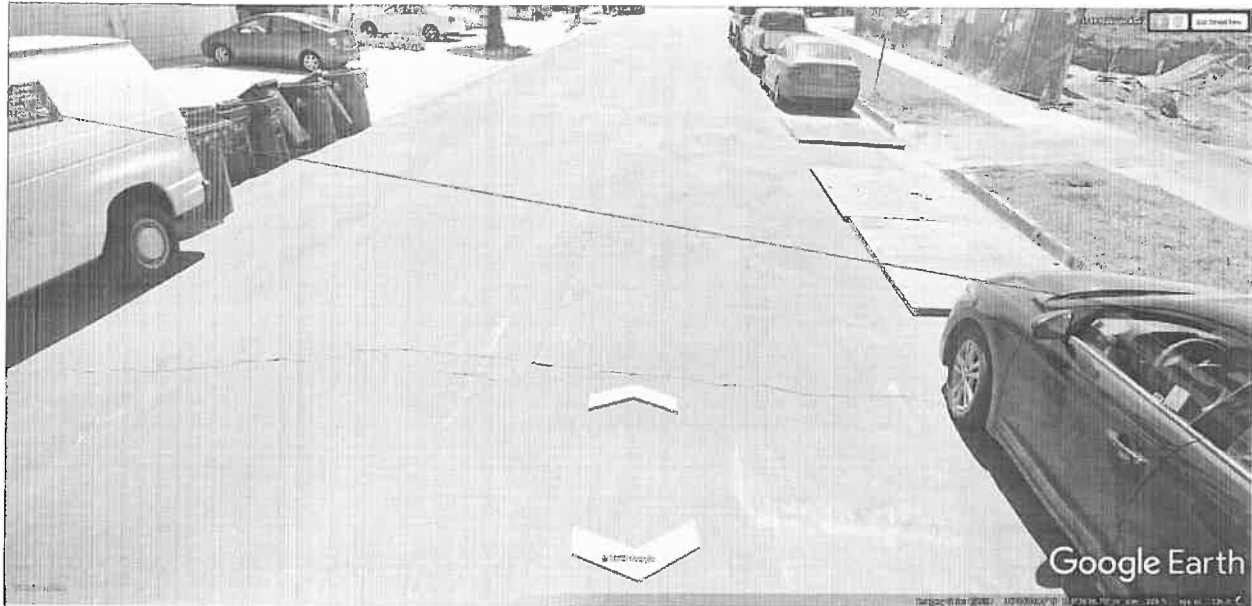
*Figure 7 Fault runs across Malcolm into site. Roadway cracks from surface faulting run into site.*

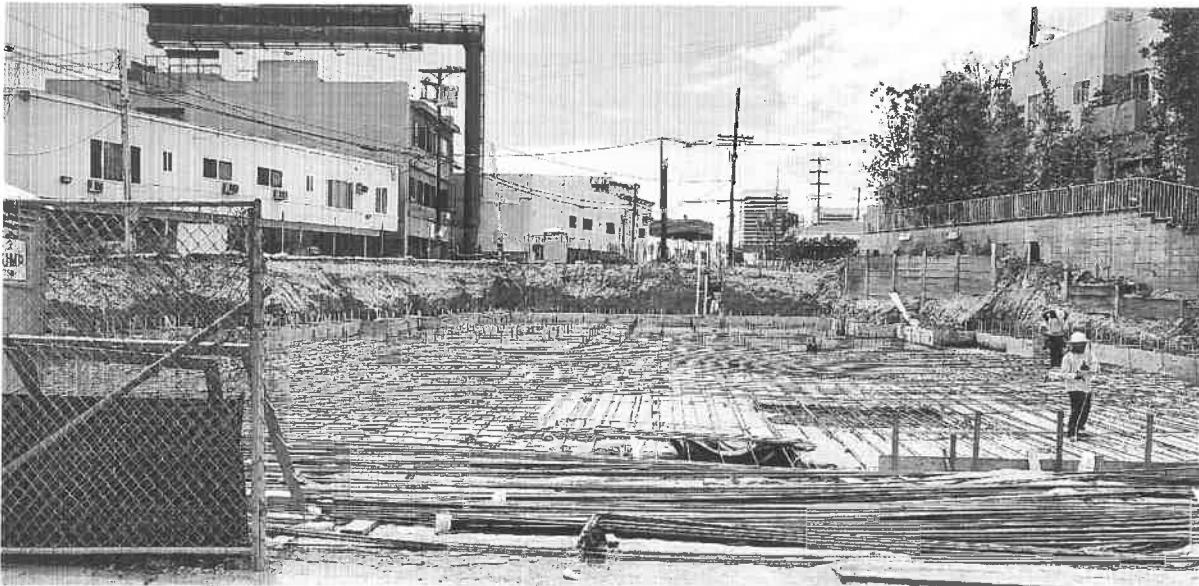
1751 Malcolm Avenue is built over the active fault viewed from Malcolm Ave. (Source: Fix the City).

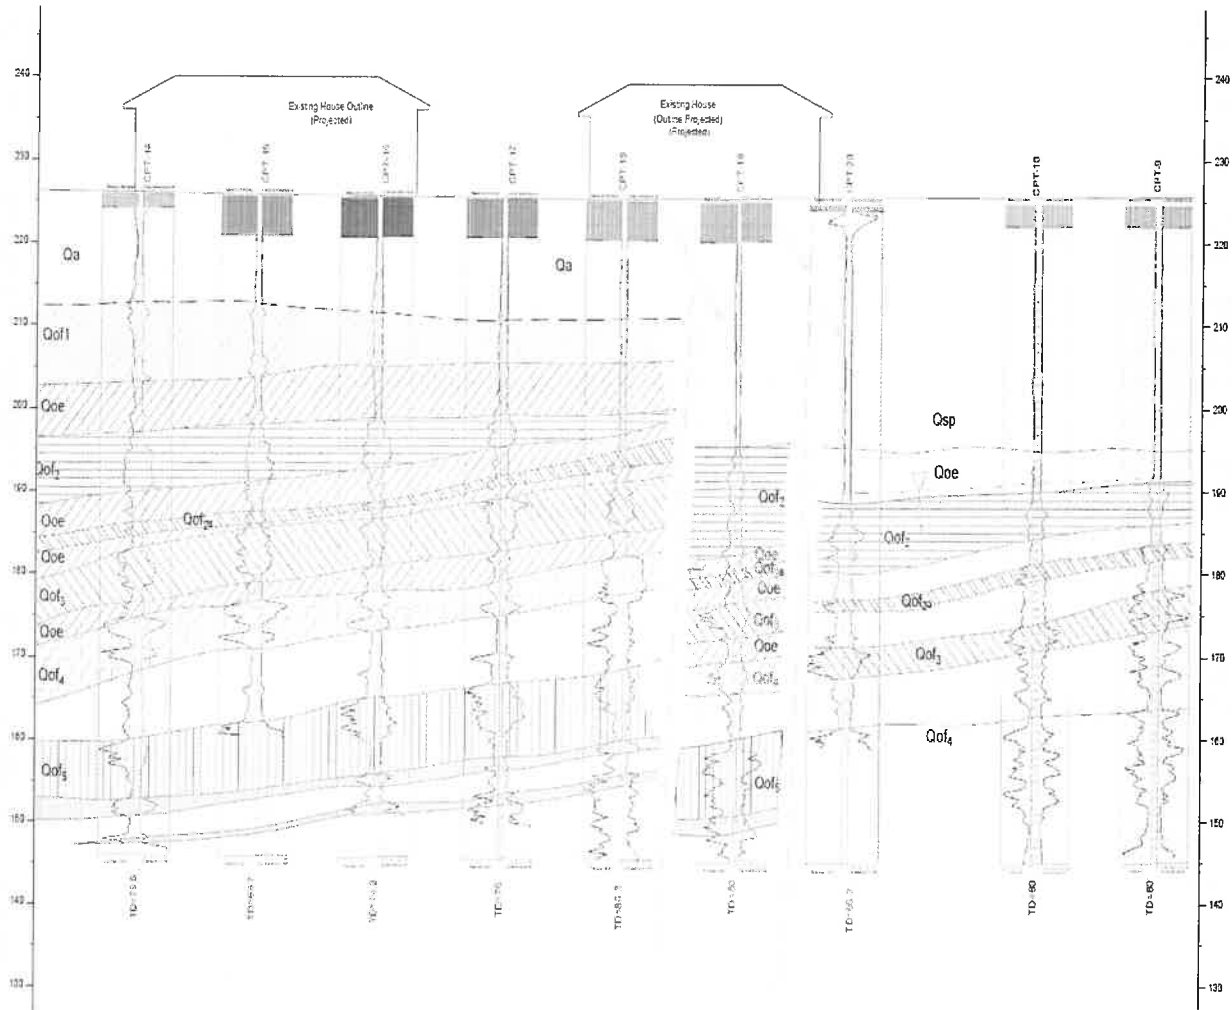
**Figure 3** CGS Figure 16: Portion of geologic cross section A-A" constructed along Malcolm Avenue by AES (2015b), Drawing 2) looking west. Note the thick sequence of Holocene "sag pond" deposits (Qsp) faulted against broadly folded Pleistocene older fan (Qof) and older estuarine (Qoe) deposits in apparent north-south-sown vertical separation. Source: CGS FER 259, p. 27.

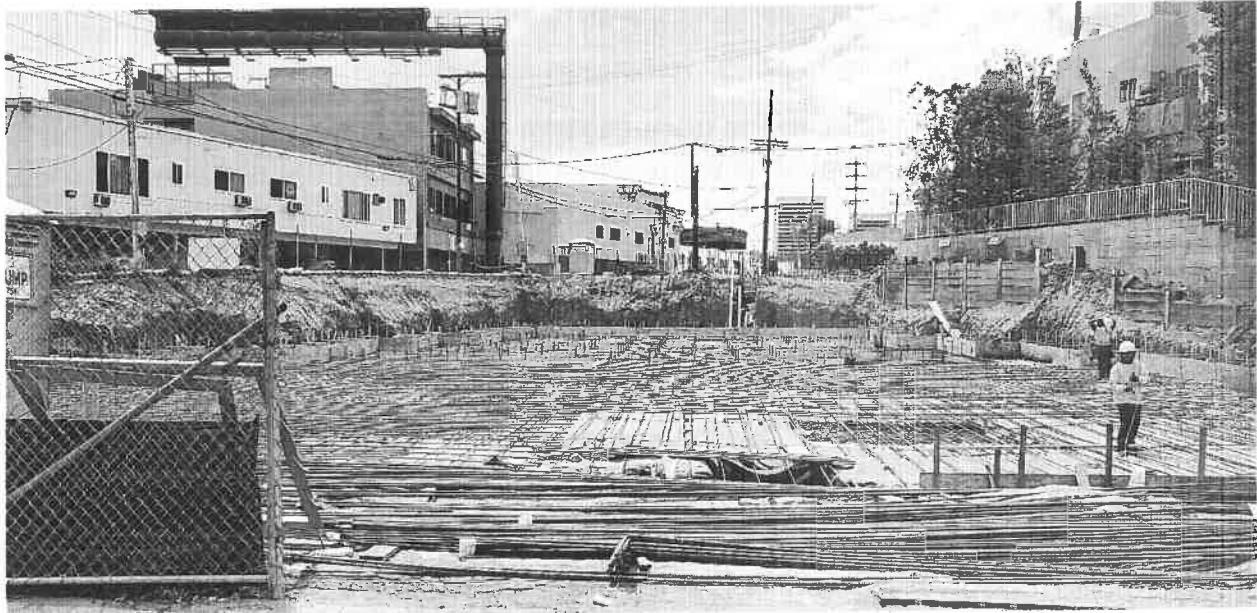
1751 Malcolm Avenue is built over the active fault viewed from Malcolm Ave. (Source: Fix the City).

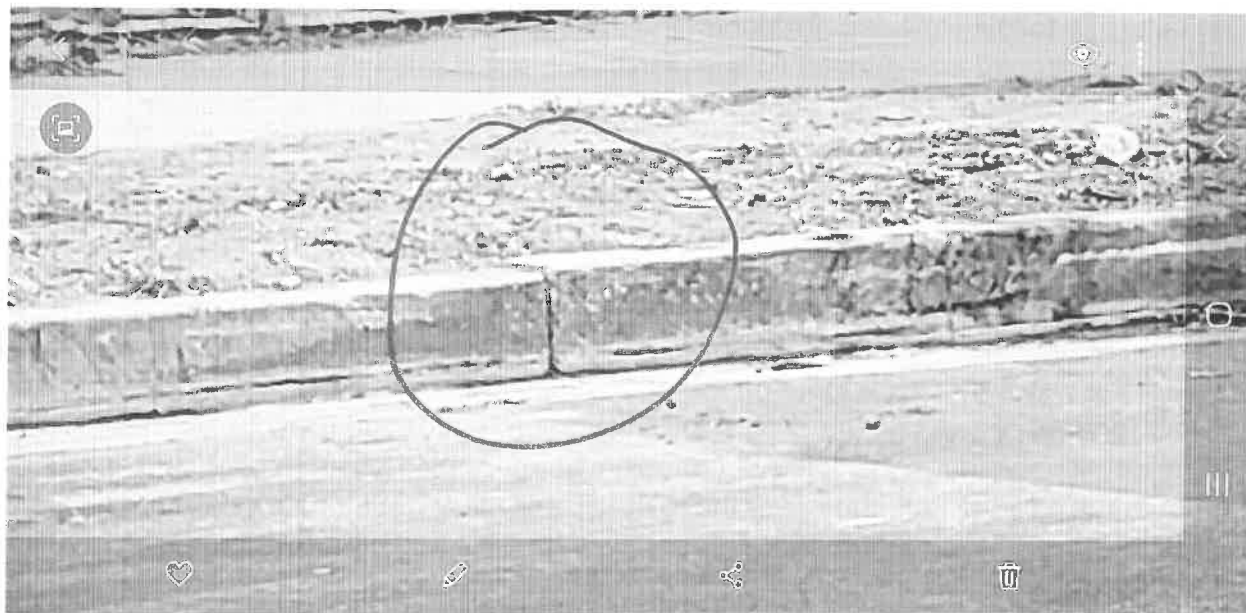
*Figure 4 broken curb at fault between CPT 18 and 19*

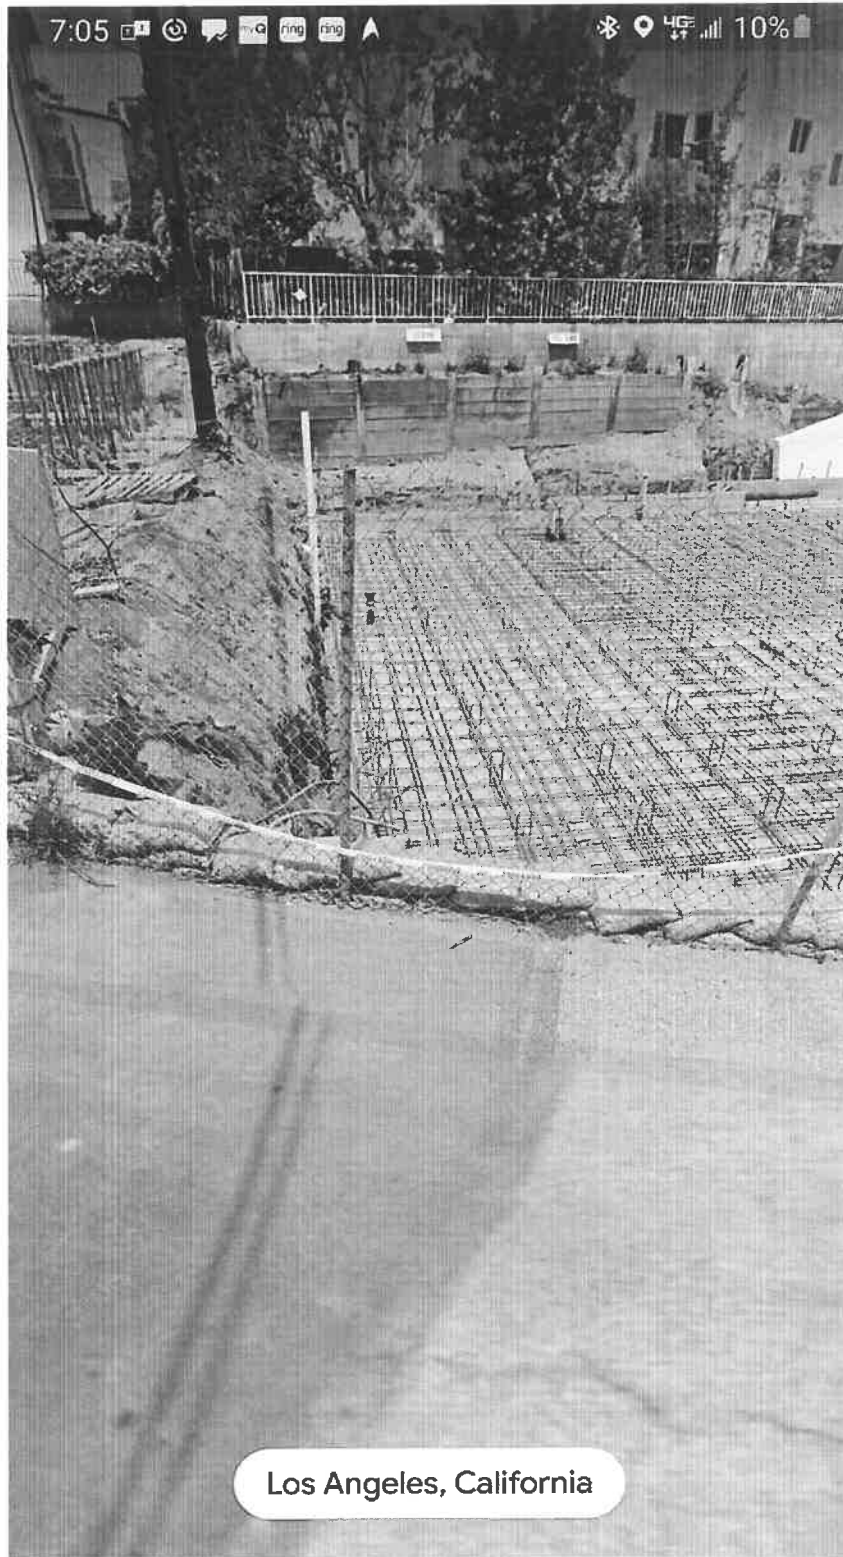
Figure 6 Fault in alley visible

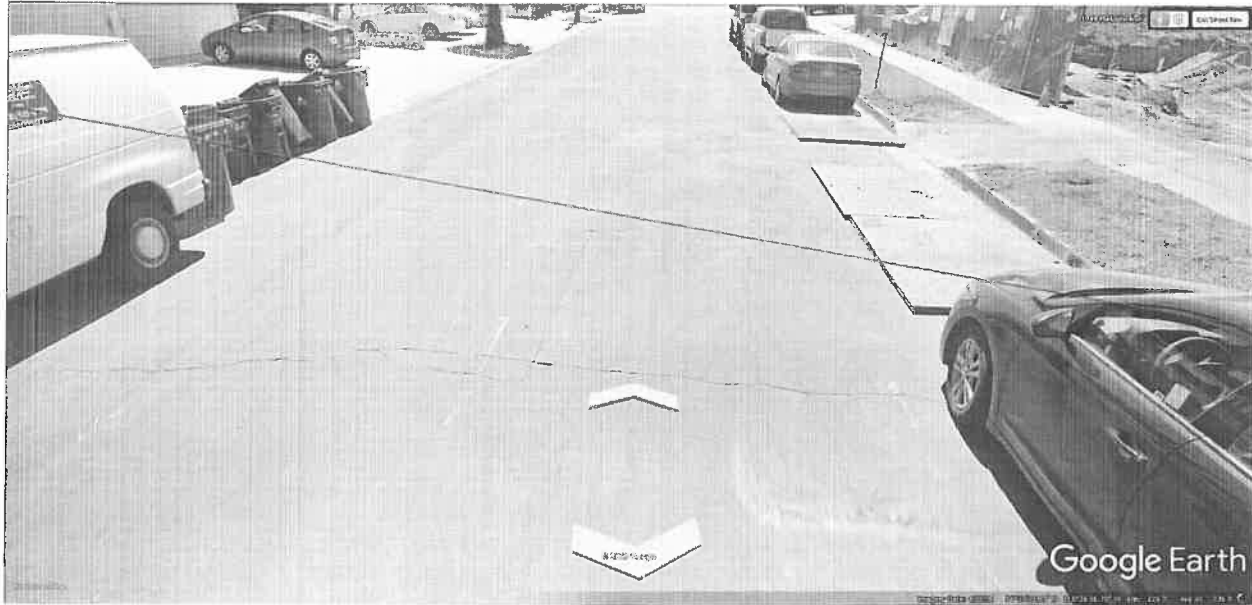
*Figure 7 Fault runs across Malcolm into site. Roadway cracks from surface faulting run into site.*
