City of Los Angeles

REPORT ON APPEAL FROM DETERMINATION OF SUPERINTENDENT OF BUILDING  
REFERRED TO THE BBSC WITHOUT RECOMMENDATION FROM THE COMMISSION STAFF

BOARD FILE: 210036  
C.D.: 5 (Councilmember Paul Koretz)  
PLANNING AREA: West Los Angeles  
ZONE: [Q]RD1.5-1  
BUREAU/DIV.: Inspection/Grading  
DISTRICT OFFICE: West Los Angeles  
PRIOR BOARD ACTION: No  
ORDER: No

JOB ADDRESS: 1751 1-12 – 1759 SOUTH MALCOLM AVENUE &  
1772 – 1774 1-6 SOUTH GLENDON AVENUE

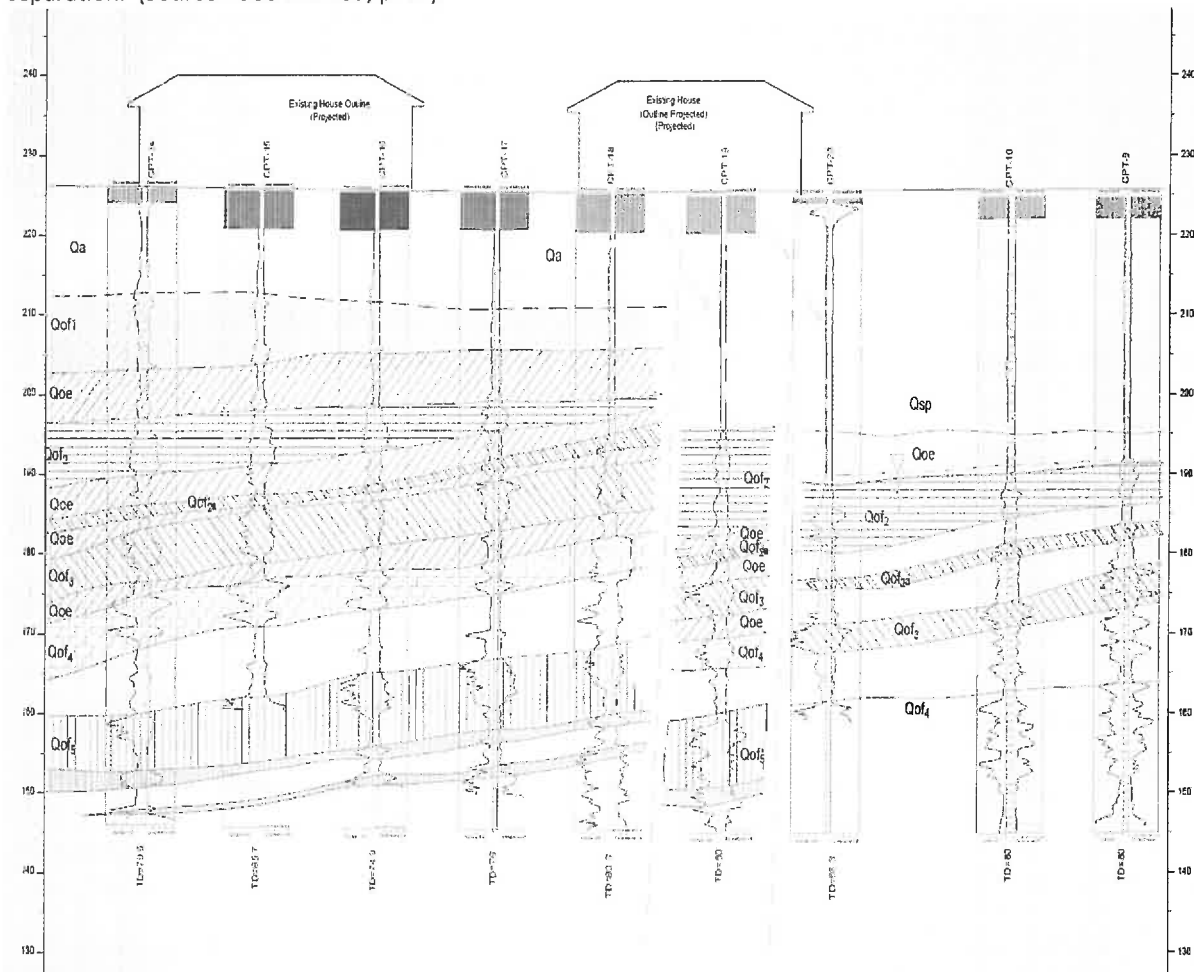
mischaracterization of the fault lying in the northeastern area of the site is contradicted by Figure 16 in CGS FER 259, p. 27. The December 29, 2015 denial summary from LADBS (Exhibit C) incorrectly claims the fault was in the **northeastern** portion of the site, when the fault rupture study on page 27 of FER 259 shows it running through the center of the site between *CPT 18* and *CPT 19* as shown below.

*In the absence of new substantial evidence in 2018, LADBS violated the clear language of CGS FER 259, the ultimate authority on fault rupture studies within the Santa Monica Fault. Approval was arbitrary and capricious, not supported by substantial evidence, and directly in conflict with CGS FER 259 and constituted a gross, prejudicial abuse of authority.*

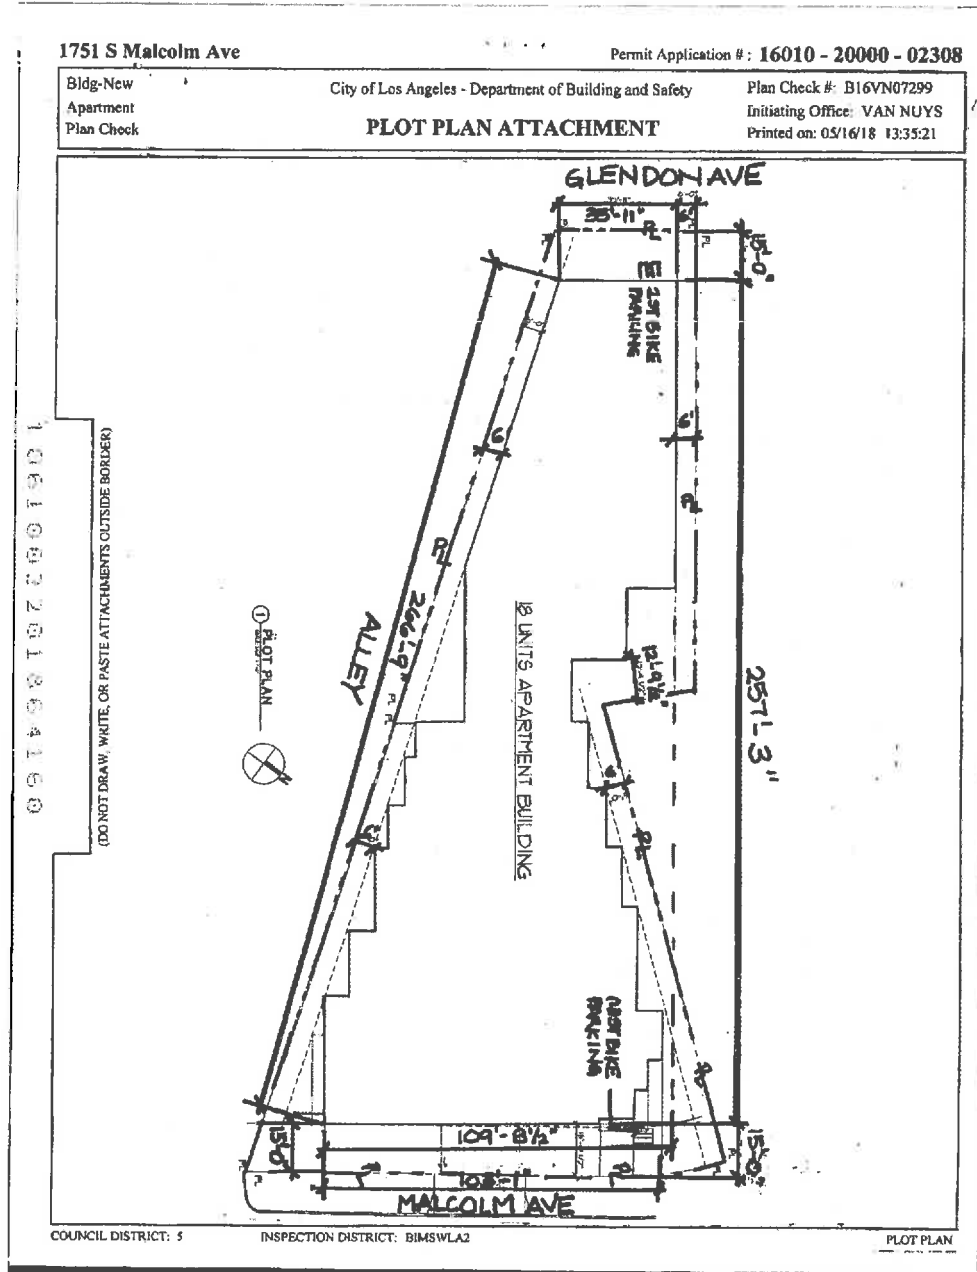
**CPT-18 and CPT-19 are NOT in the northeastern portion of the site.** They are on the right side of the garage entrance shown in the photo above. The plot plan attached to the building permit, shown on the next page, shows that the entire site was built over with a few zig-zags on the northern boundary and not around CPT 18 and CPT 19.

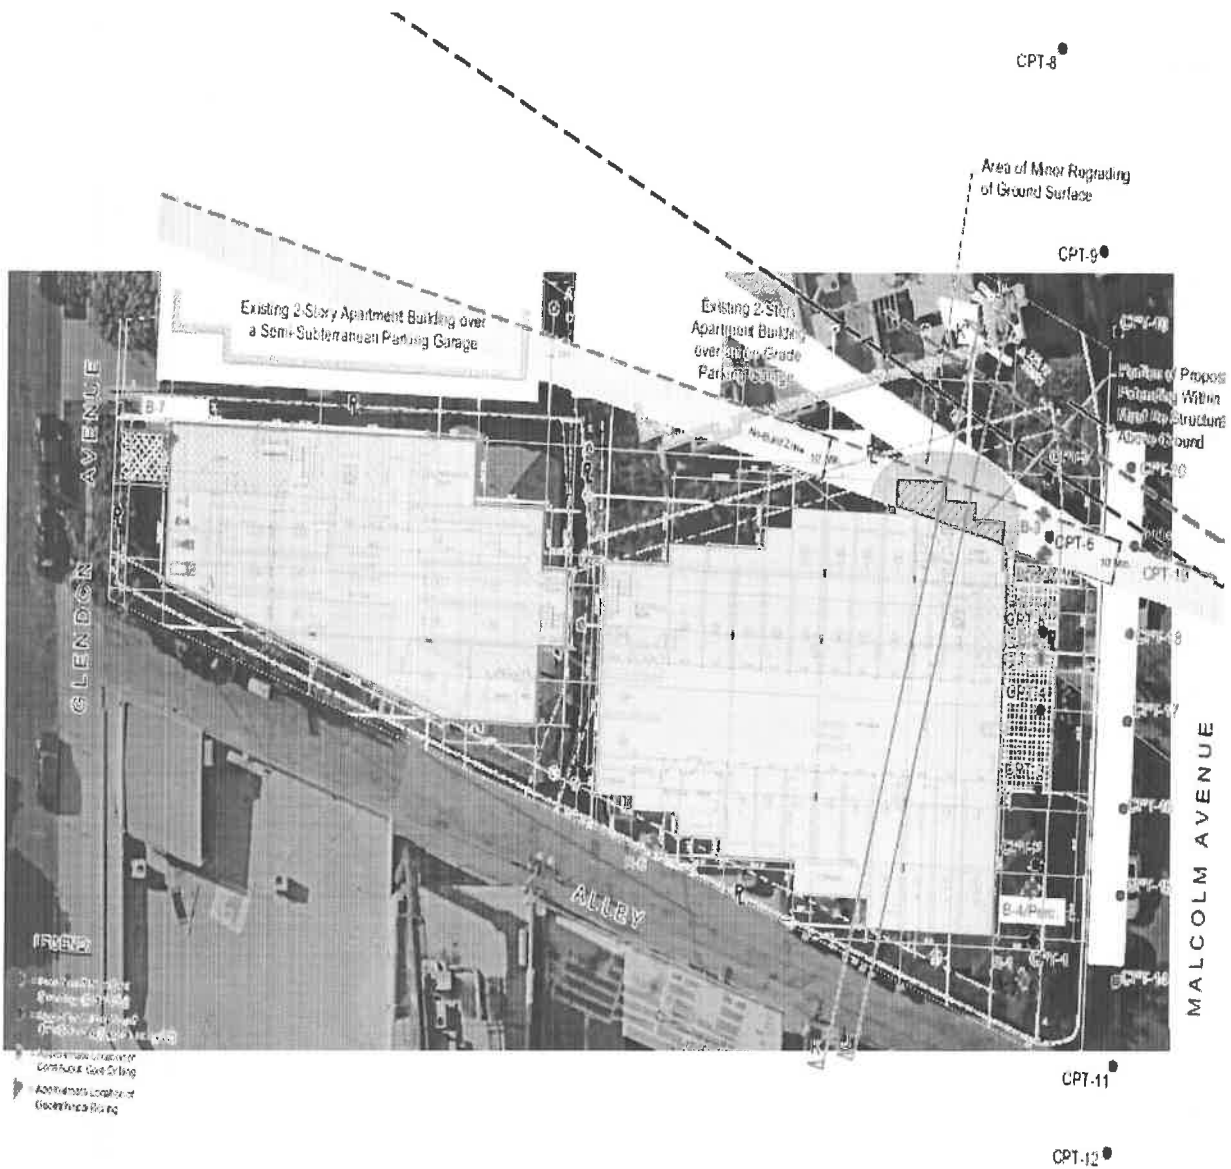
Figure 1. Fault line at southern boundary of 1772 Glendon Avenue not investigated – requires 50-foot setback.

Based on CGS and USGS fault lines within the AP Fault Map for this site, the **City failed to require an investigation of the fault on the southern boundary** of 1772 Glendon Avenue and 1751 Malcolm Avenue as shown above in Figures 1 and 2. **This was a gross prejudicial abuse of authority.**

The City does not have authority to waive the study and waive the required 50-foot setback. Under **California Resources Code Section 2623** the City may impose stricter requirements, but may not substitute weaker local requirements.

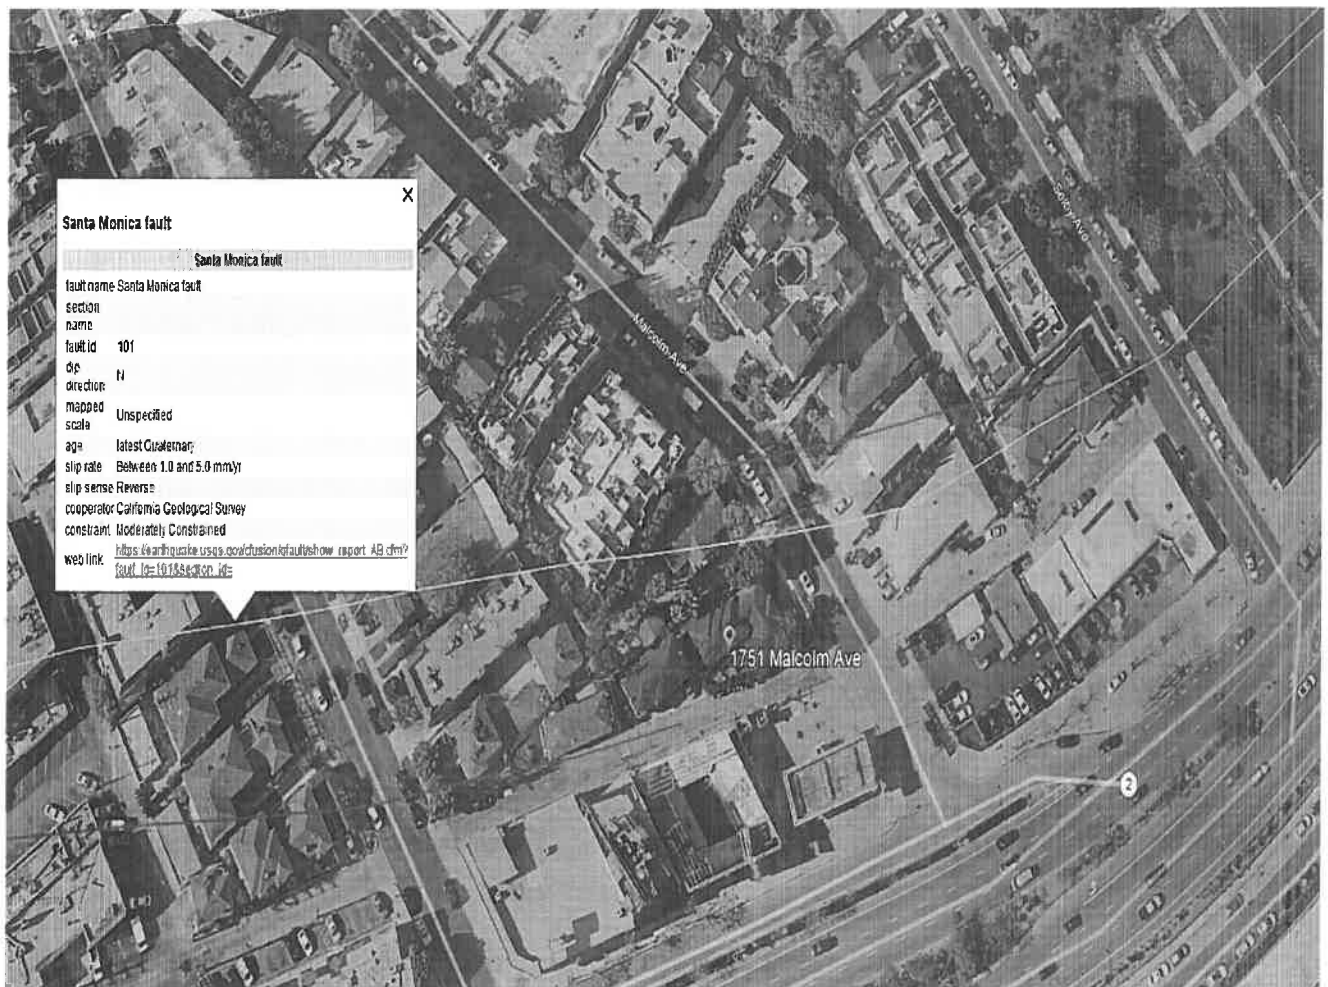
Figure 2 Entire site within Santa Monica Fault Zone with second red fault line at south

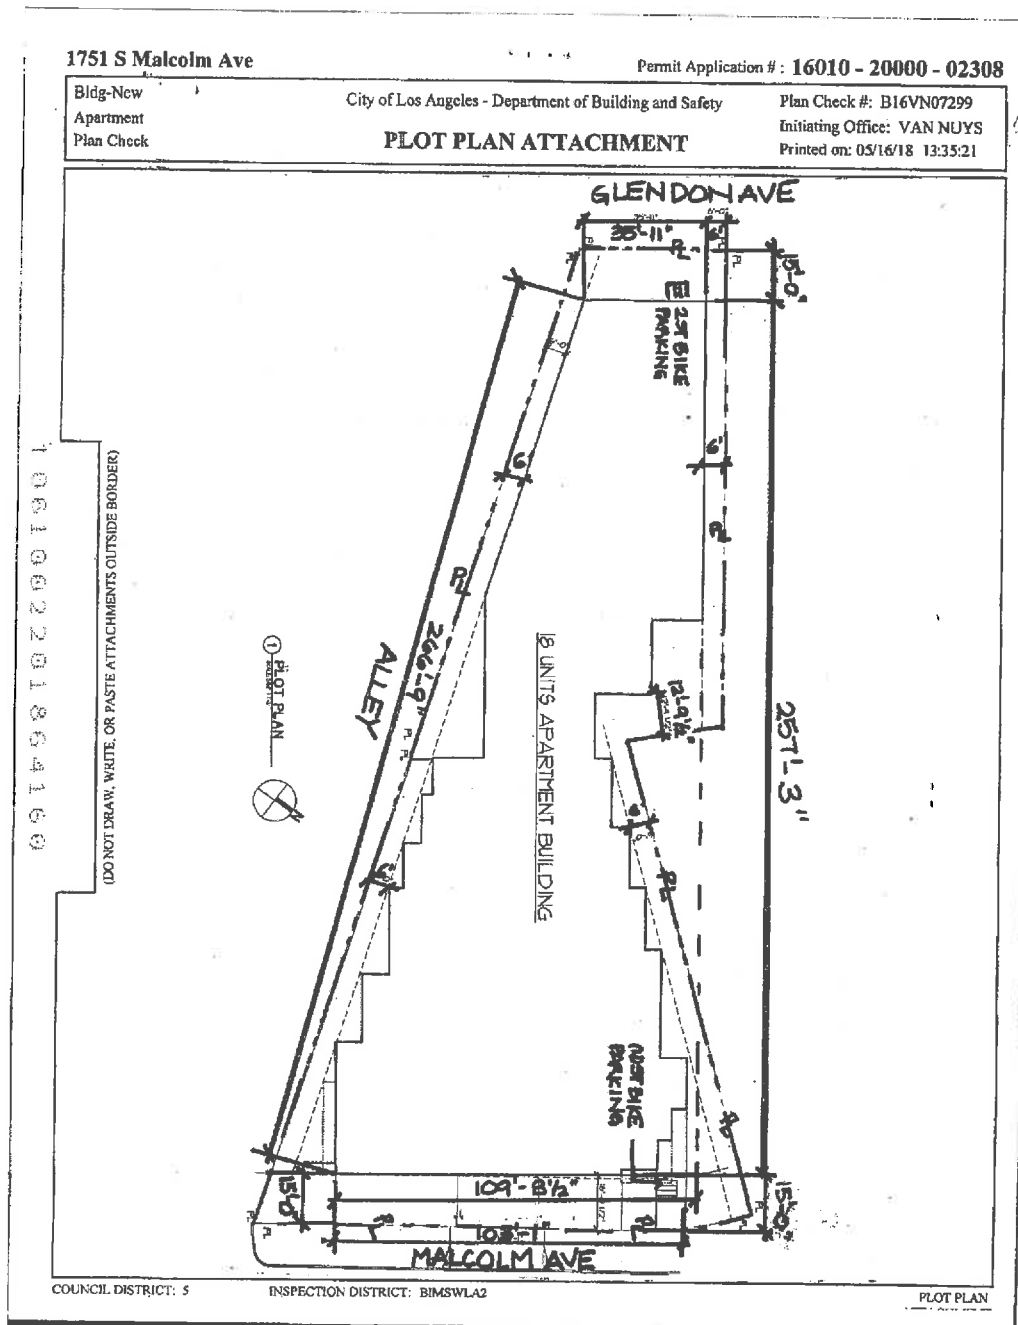
CPT-18 and CPT-19 are NOT in the northeastern portion of the site. They are on the right side of the garage entrance shown in the photo above. The plot plan attached to the building permit, shown on the next page, shows that the entire site was built over with a few zig-zags on the northern boundary and not around CPT 18 and CPT 19.

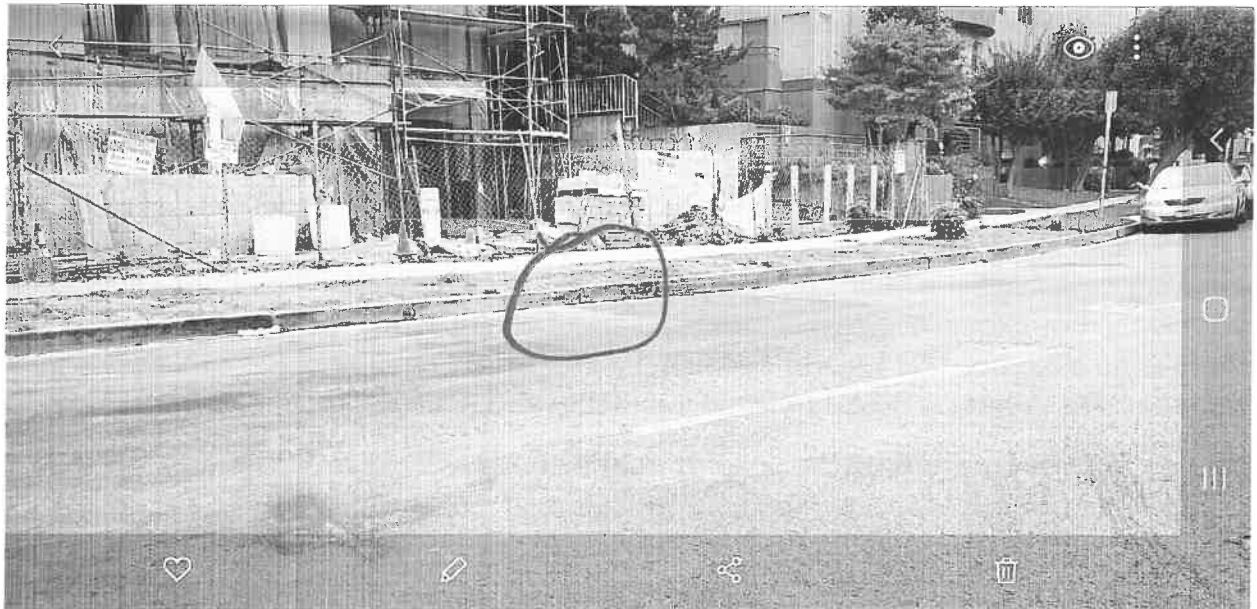
*Figure 4 broken curb at fault between CPT 18 and 19*

*Figure 5 rupture on Malcolm curb in front of no-build area*

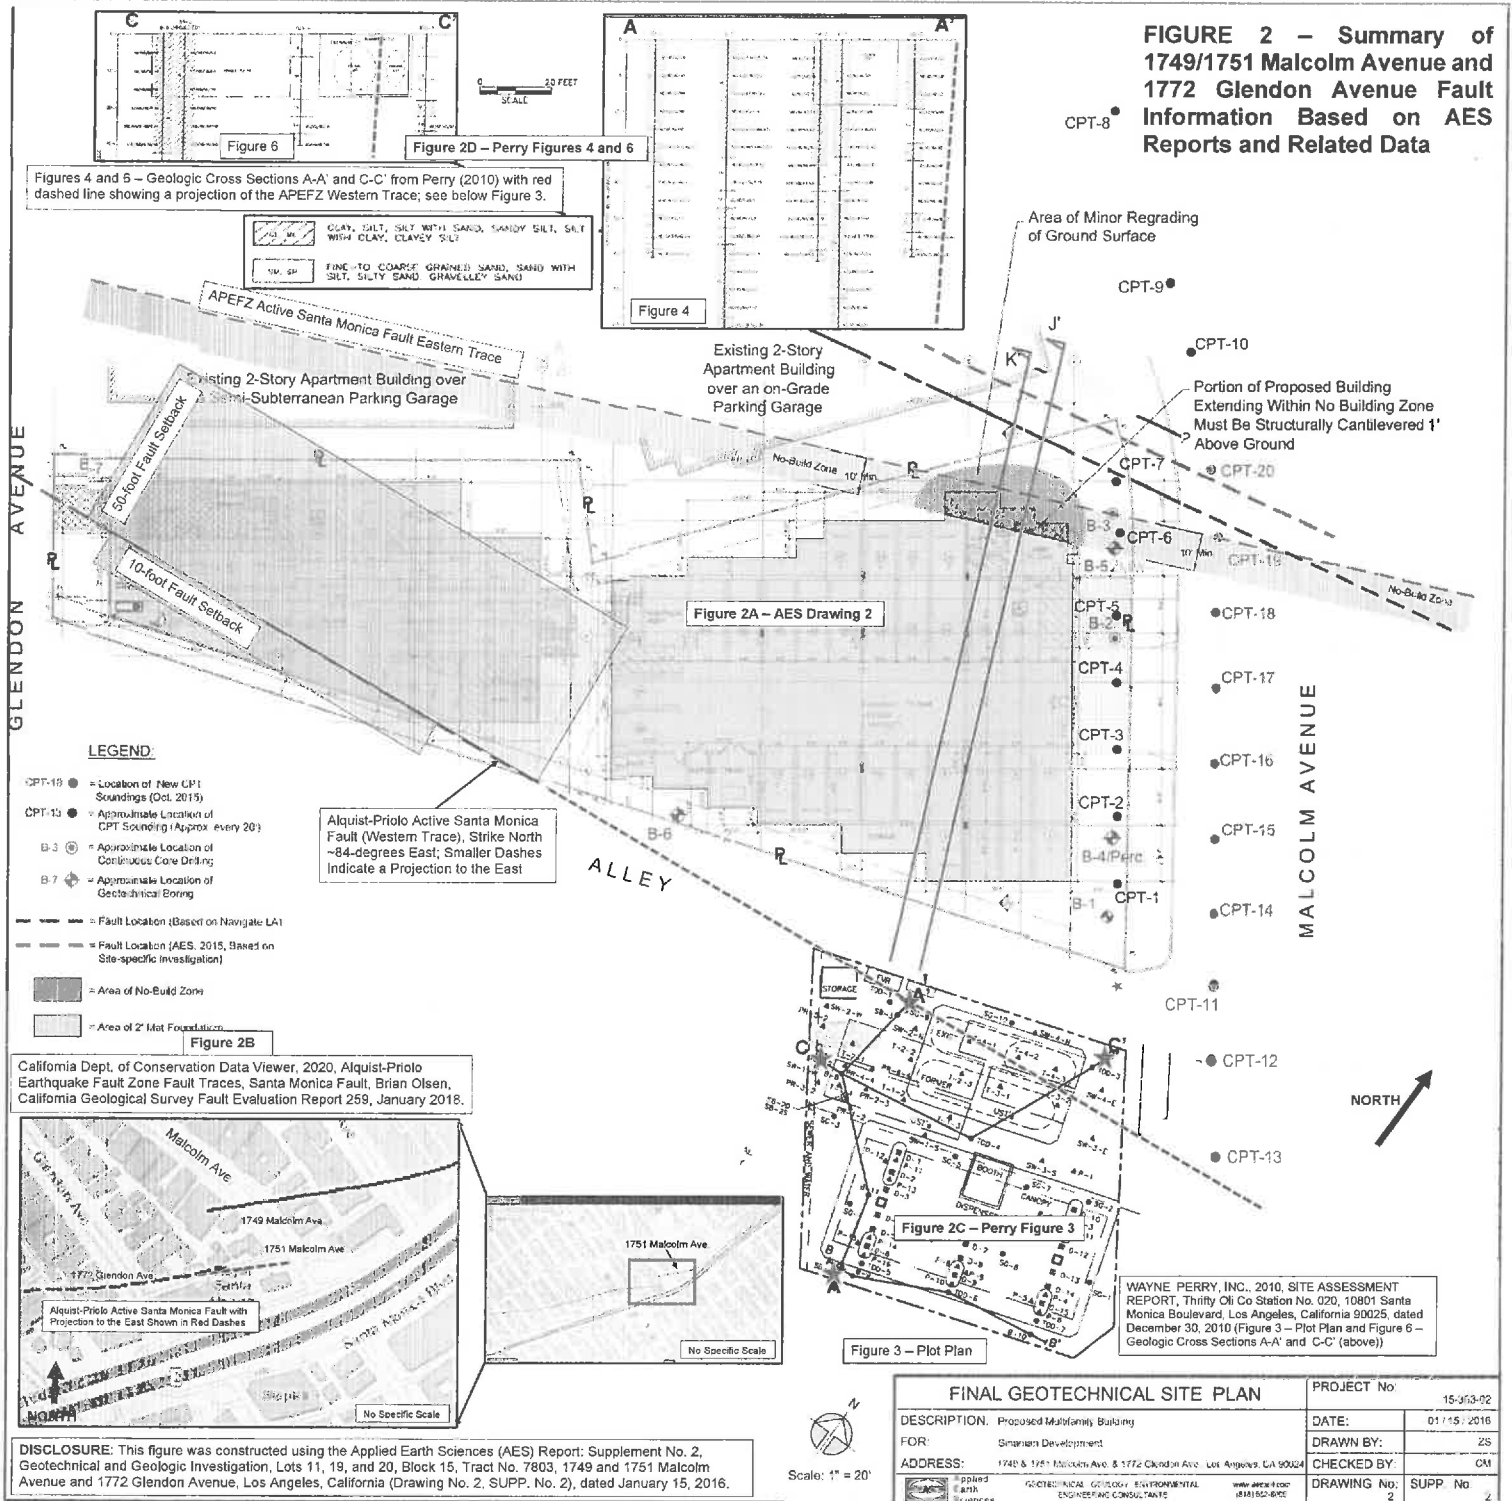
**FIGURE 2 – Summary of 1749/1751 Malcolm Avenue and 1772 Glendon Avenue Fault Information Based on AES Reports and Related Data**

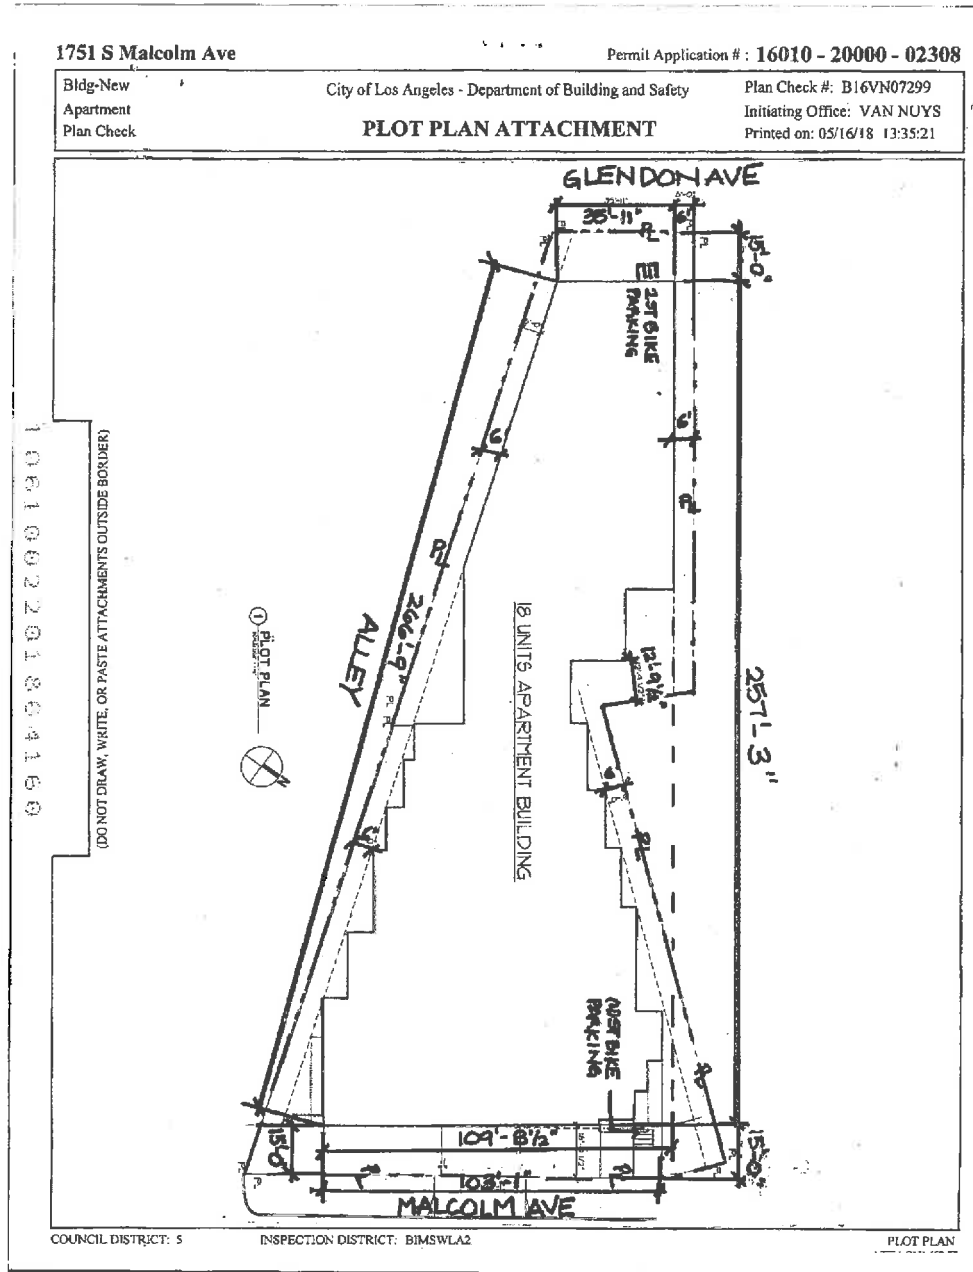
**CPT-18 and CPT-19 are NOT in the northeastern portion of the site.** They are on the right side of the garage entrance shown in the photo above. The plot plan attached to the building permit, shown on the next page, shows that the entire site was built over with a few zig-zags on the northern boundary and not around CPT 18 and CPT 19.

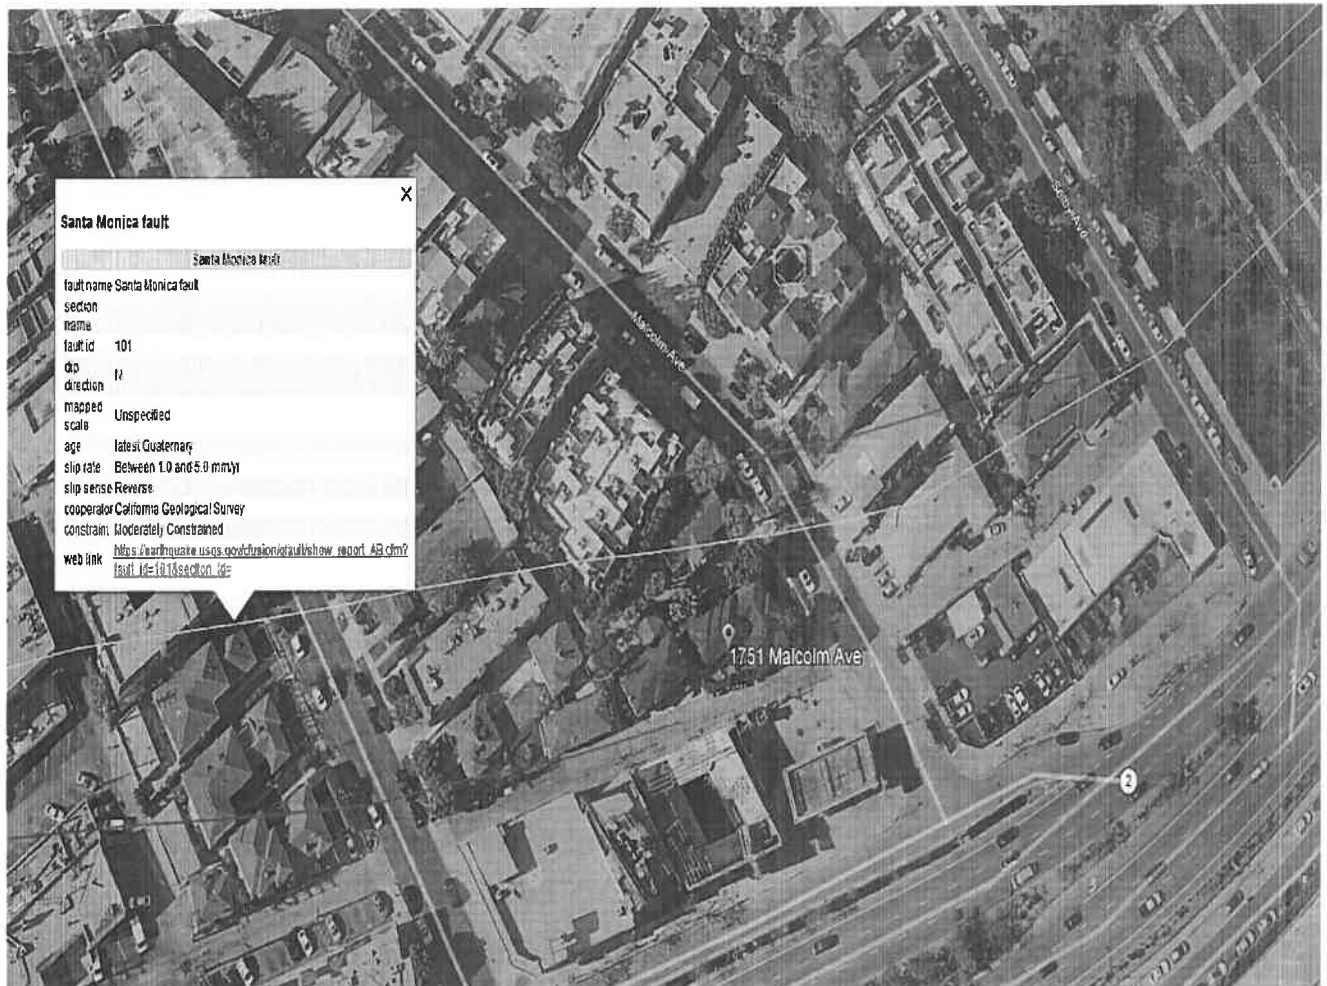
Figure 2 Entire site within Santa Monica Fault Zone with second red fault line at south

The City does not have authority to waive the study and waive the required 50-foot setback. Under **California Resources Code Section 2623** the City may impose stricter requirements, but may not substitute weaker local requirements.

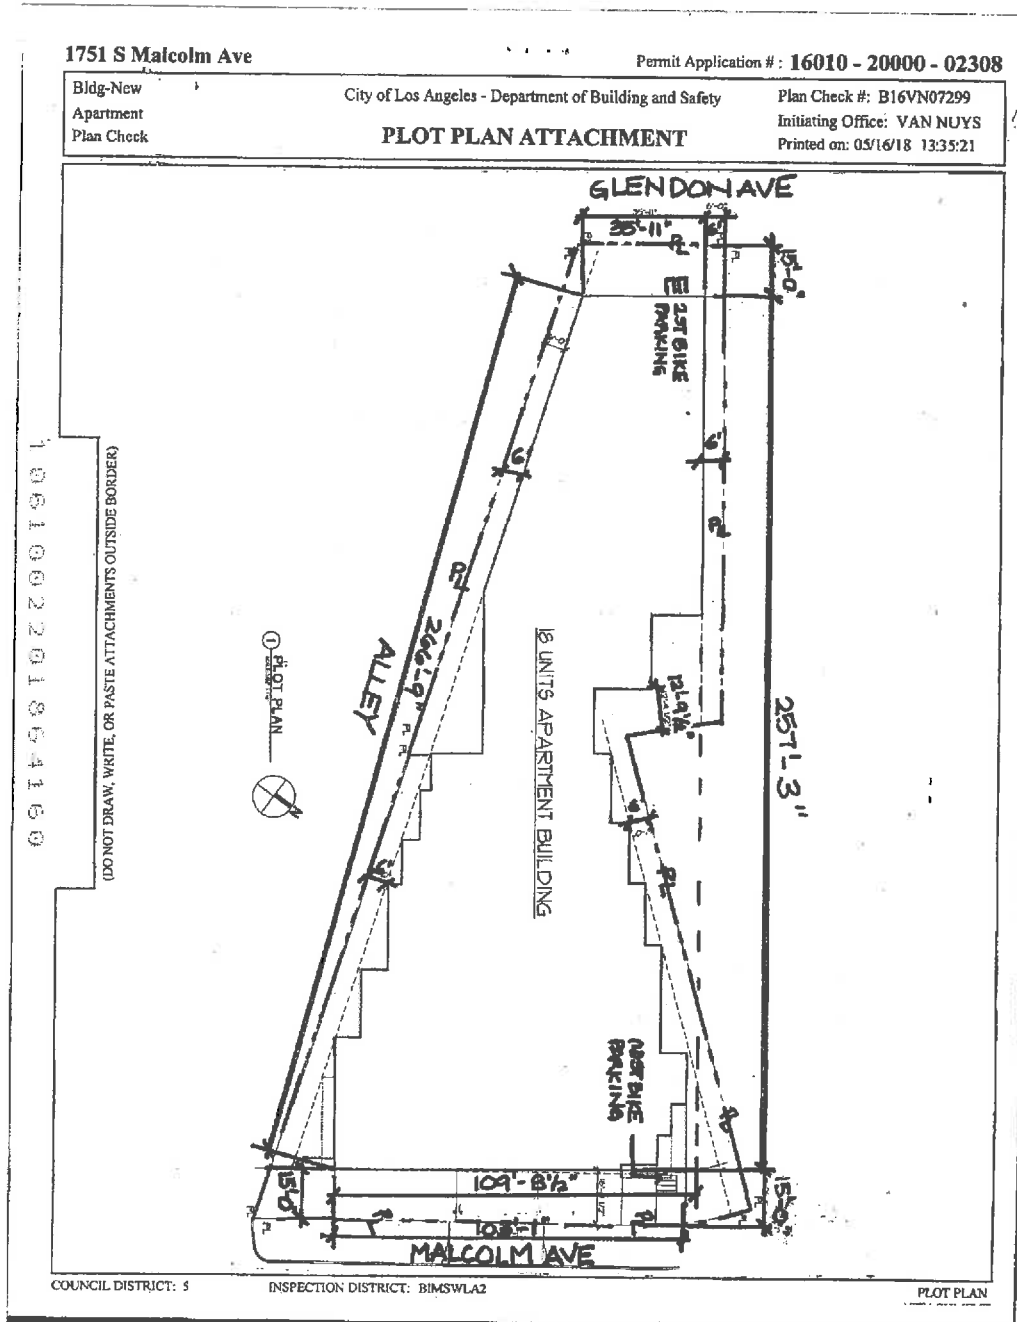
CPT-18 and CPT-19 are NOT in the northeastern portion of the site. They are on the right side of the garage entrance shown in the photo above. The plot plan attached to the building permit, shown on the next page, shows that the entire site was built over with a few zig-zags on the northern boundary and not around CPT 18 and CPT 19.

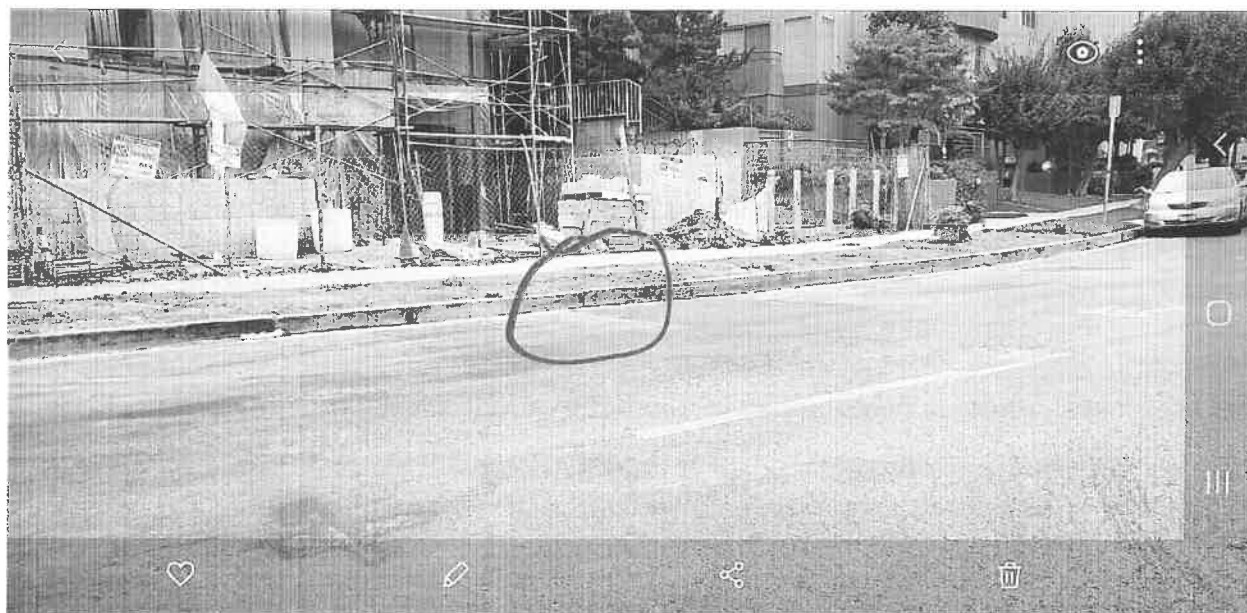
*Figure 4 broken curb at fault between CPT 18 and 19*

*Figure 5 rupture on Malcolm curb in front of no-build area*
